Evaluation & Prioritization of Erosion Control Projects at Camp Atterbury Joint Maneuver Training Center, Indiana

Heidi R. Howard, Daniel R. Gambill, and Niels G. Svendsen

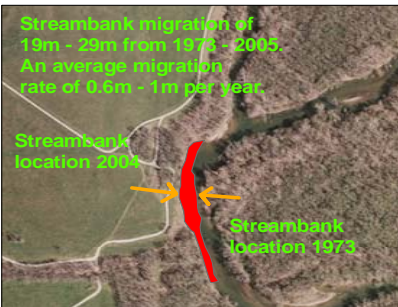
Historical aerial photos were used to detect stream bank migration over time and determine active vs. inactive erosion on bare ground. Historical aerial photographs from 1974 and 1984 along with satellite imagery of CAJMTC from 1999 and 2004 were used with a geographic information system (GIS) to find evidence of erosion. All ranges were viewed from the 2004 images on ArcGIS® for a general overview. For the majority of upland sites, rill and gully erosion was visible on the 2004 satellite imagery. It should be noted that woody debris and fallen timber was mistaken for rill and gully erosion on three sites marked as possible erosion areas.

Streambank erosion was assumed when comparisons between images revealed significant bank migration. Preliminary site areas, perimeters, and migration rates were calculated using the polygon tool in ArcGIS®. This was possible because the 2004 image was rectified and accurate to within 1 meter. By comparing these remote sensing images most possible or known erosion sites were documented and recorded using ArcGIS®. The erosion site locations and possible hotspots found during the electronic search were used as reference for three field surveys during June, July and August 2005 and April 2006.
