# Edge-of-Field Water Quality in Surface and Subsurface Runoff from Paired Cornfields

Eric O. Young<sup>1</sup>, Stephen R. Kramer<sup>1</sup>, and Laura B. Klaiber<sup>1</sup>

<sup>1</sup>William H. Miner Agricultural Research Institute, Chazy, NY

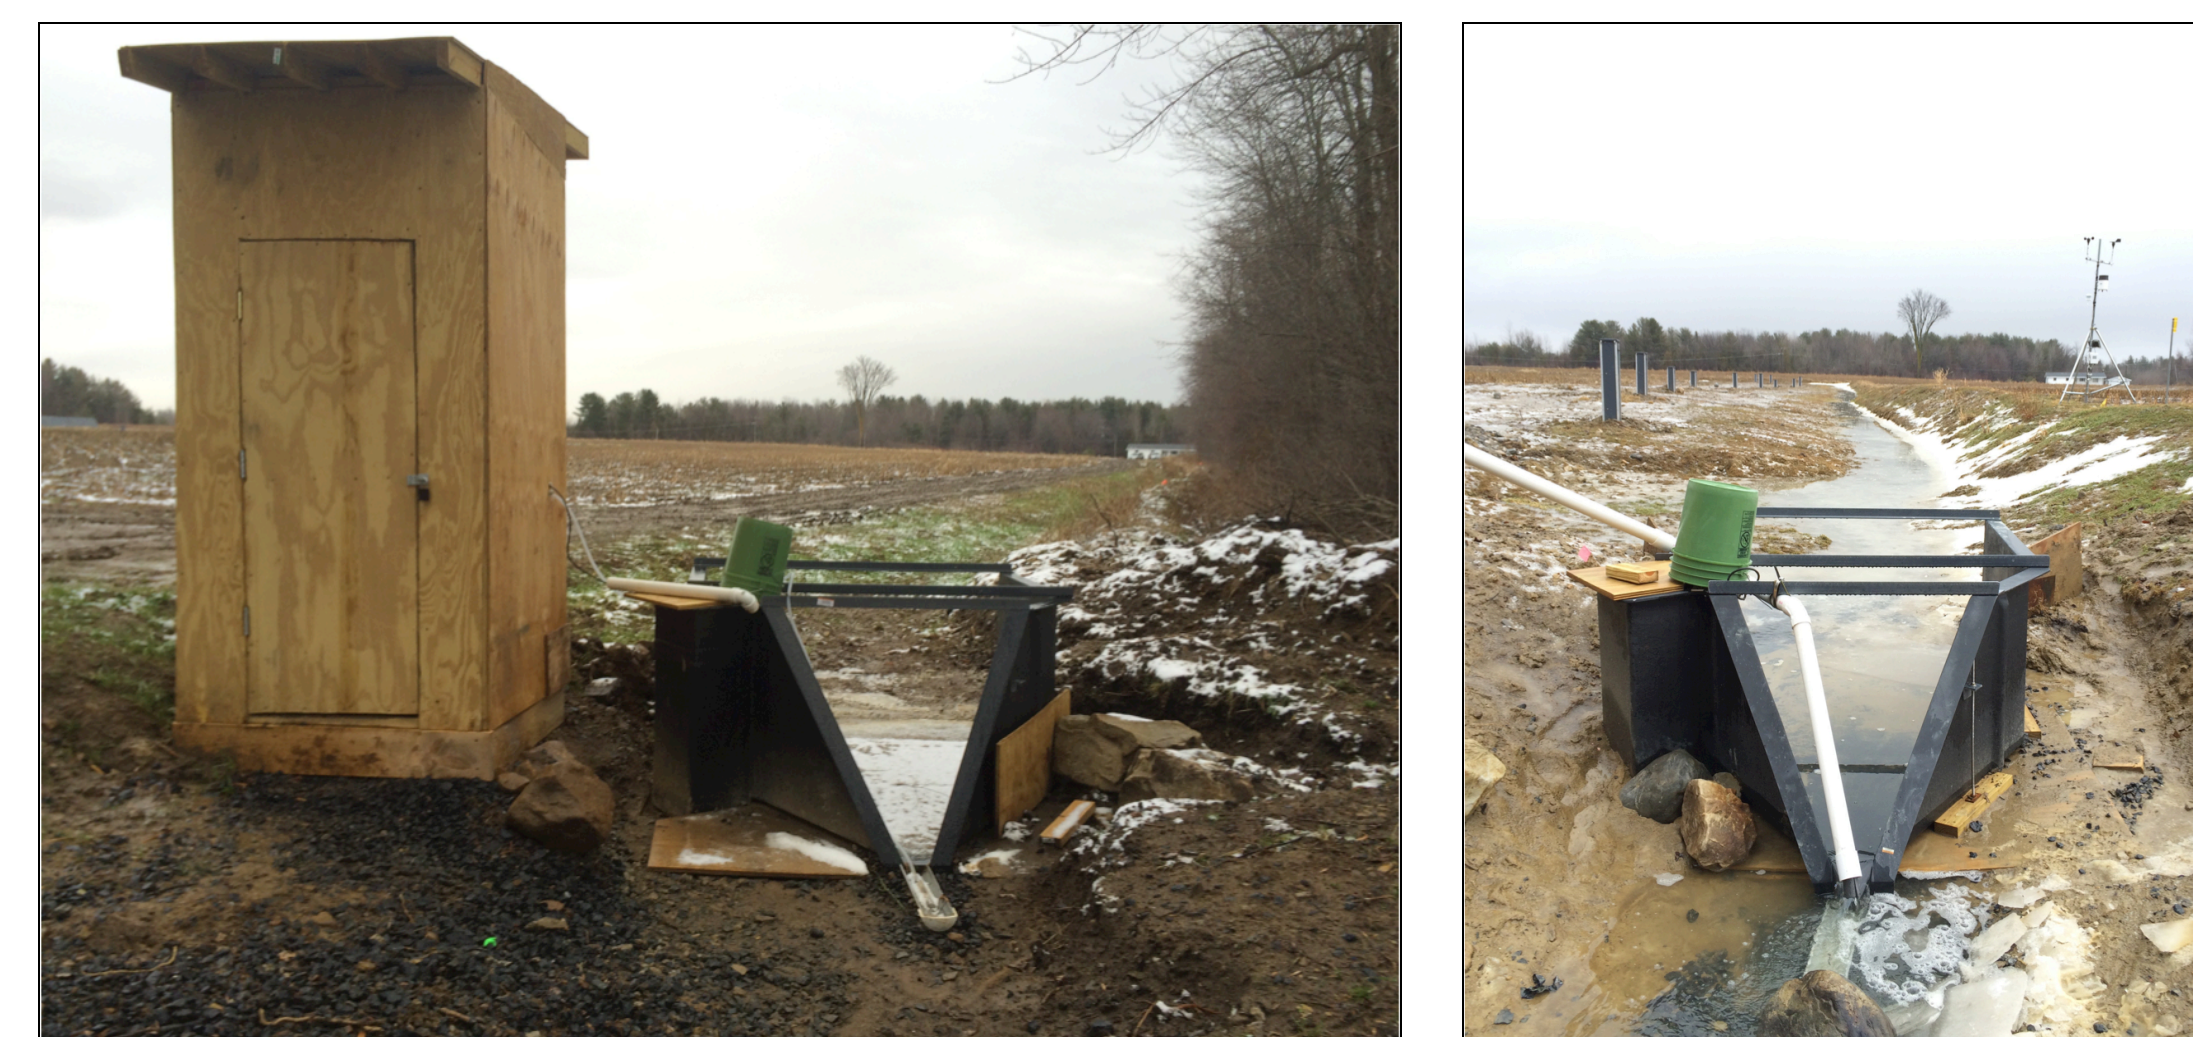
Figure 2. Surface water flume for field A (left) and field B (right).

- Drainage water control structures (Agri-Drain Corp., Adair, IA) were installed on individual tile drain lateral lines in April 2015 (Fig. 2).
- Subsurface and surface runoff water system designs were completed by River Bend Ag and Environmental Services, Altona NY. The tile drainage system was installed by Barnes Excavation, Plattsburgh, NY.

- Surface water runoff is gauged with pre-calibrated H-flumes (Openchannelflow, Atlanta, GA) with Ultrasonic sensors to measure water height and is then converted flow.
- Flow-based samples were taken by autosamplers (Fig. 3) and event mean concentrations were multiplied by runoff volumes to estimate *flow weighted mean* loads for runoff events. Data reported here represent events from captured from 10/29/15 to 3/25/16.

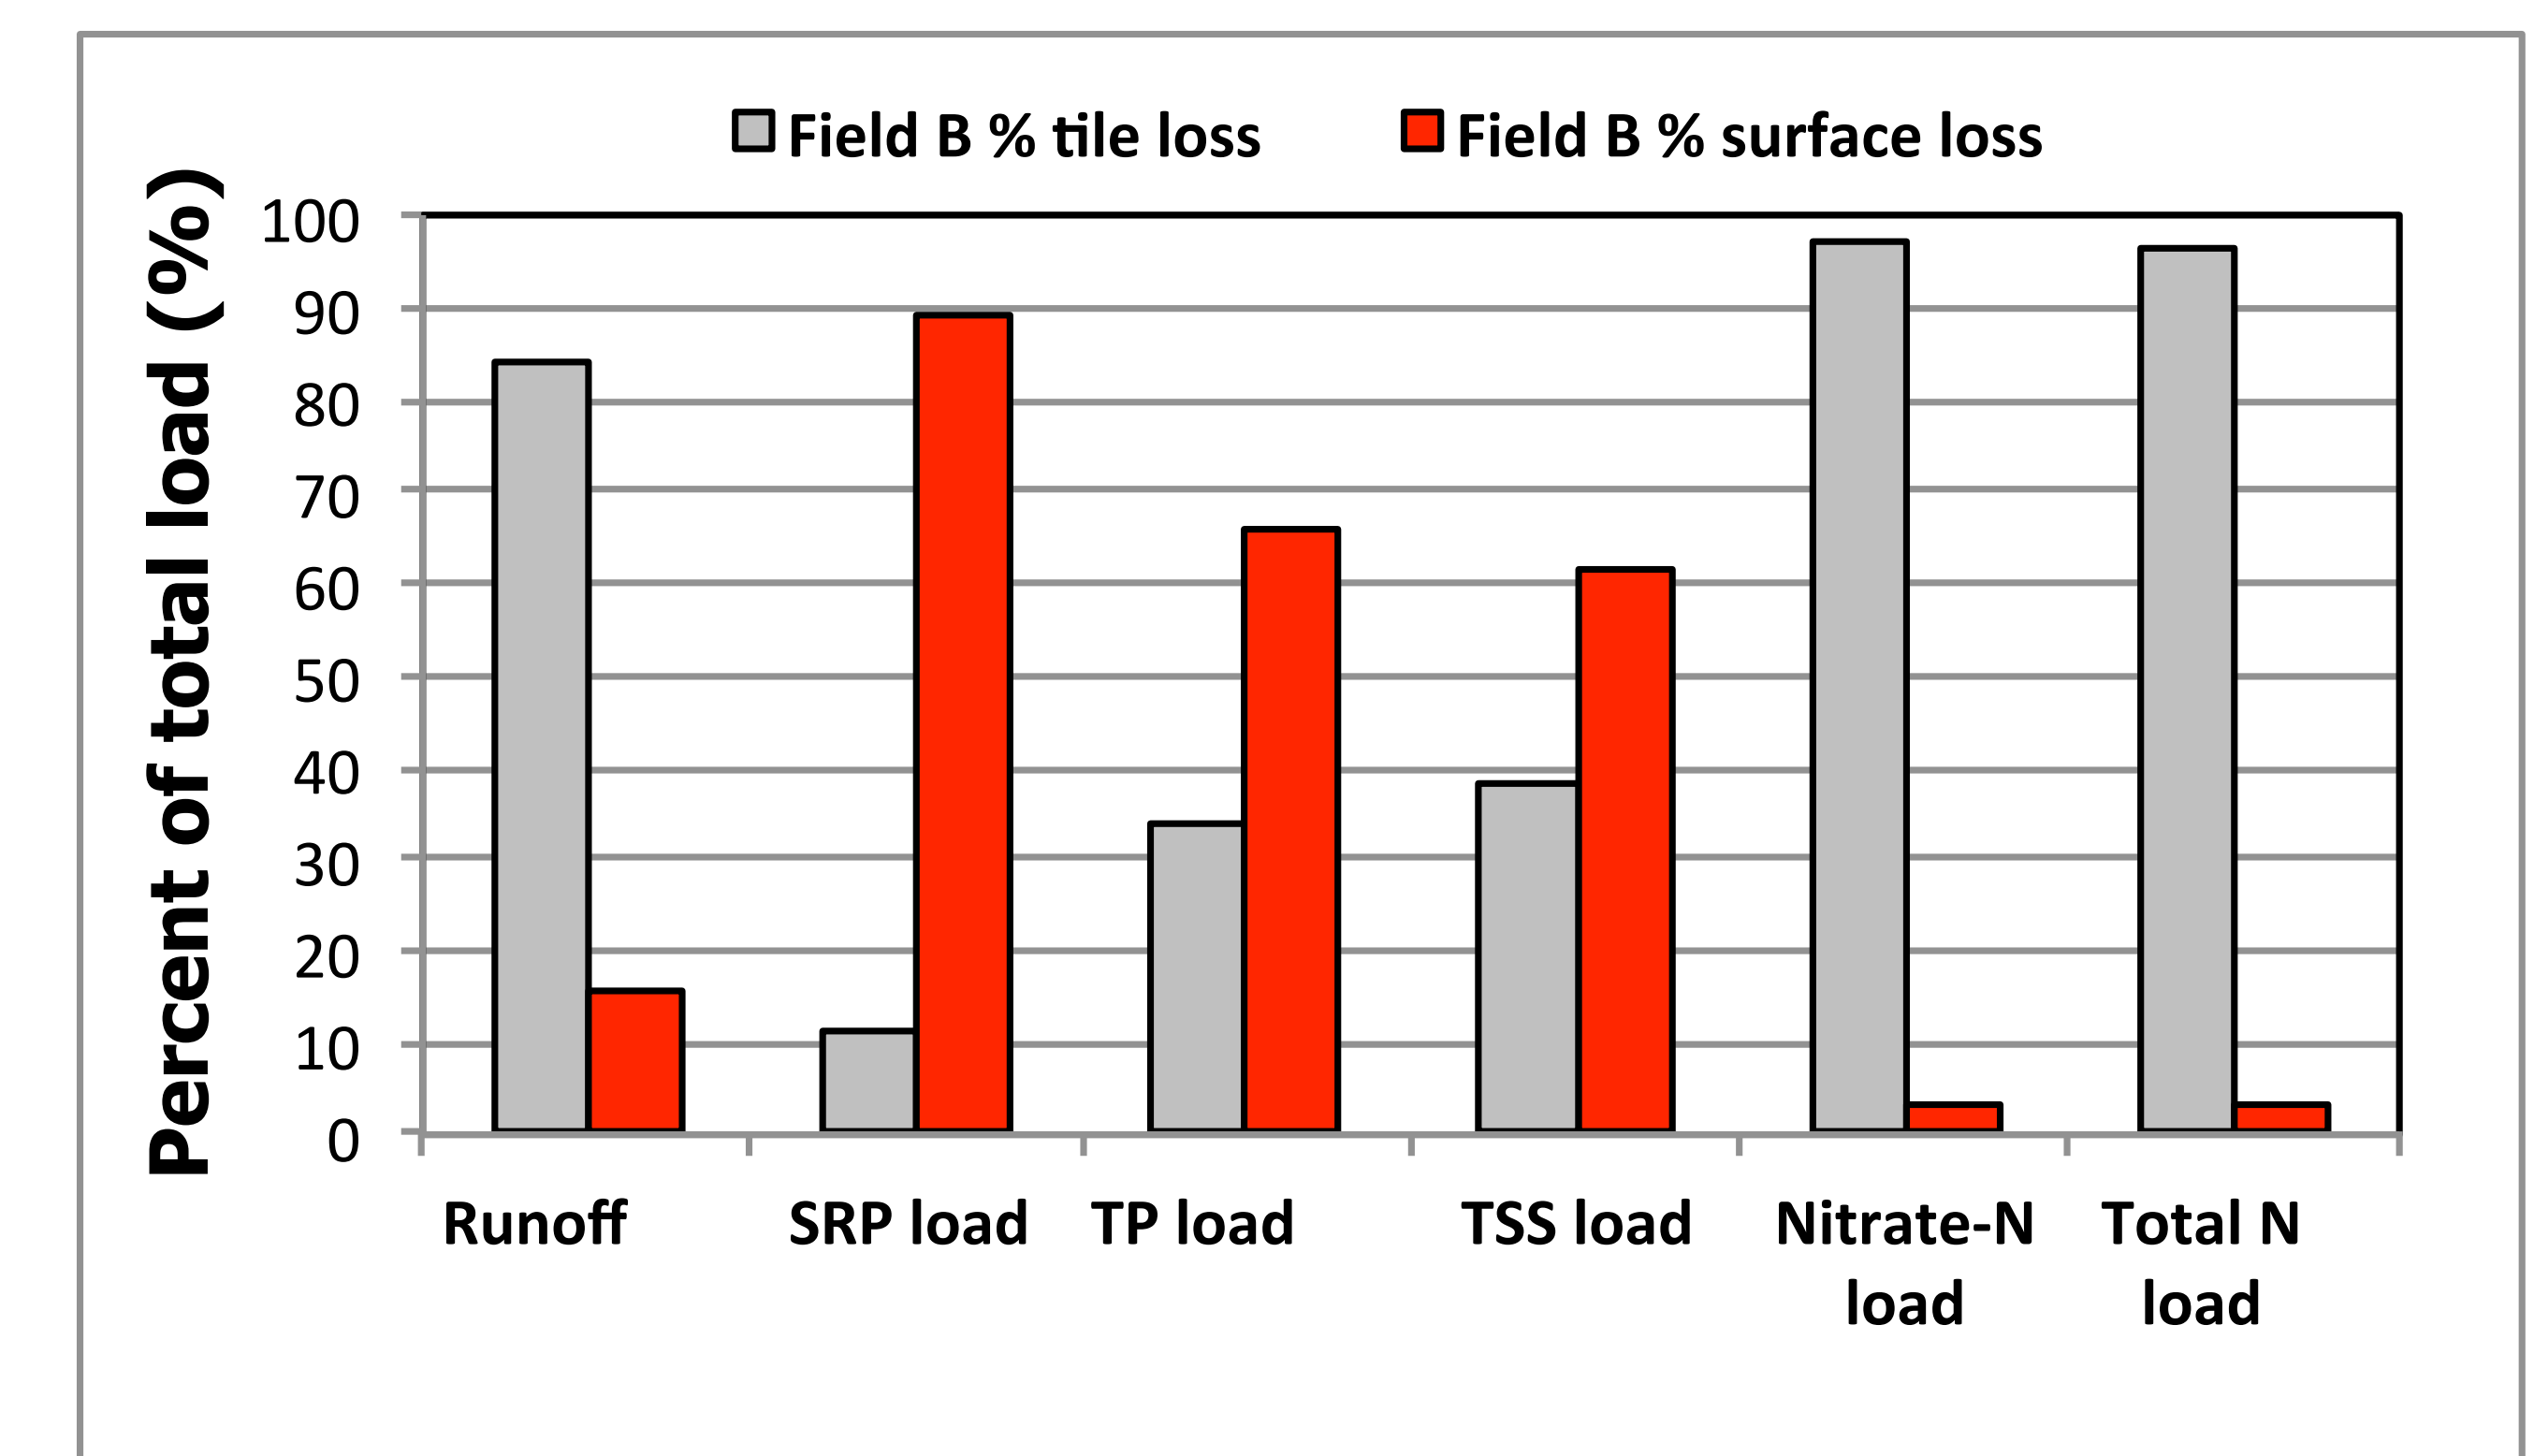
Figure 5. Percentage of load as surface or subsurface runoff or tile drain flow for field B.

- Broadly similar export patterns for N and P between the fields occurred (Fig. 4 and 5).
- 77 to 84% of runoff was through tile drainage, yet nearly 90% of SRP loss was due to surface water runoff and 66 to 78% of TP loss was in surface runoff (Fig. 4 and 5).
- Nitrate-N load was nearly all from tile drainage flow and in the form of nitrate-N.
- P appears to be transported mainly in surface runoff for the events captured.
