Ecosystem Development of a Riparian Restoration Site in West Tennessee

P.M.Gale, T. Blanchard, E.Walker – Univ. Tennessee at Martin
J. Ruddell, C. Corley – Lhoist North America - Spinks Clay

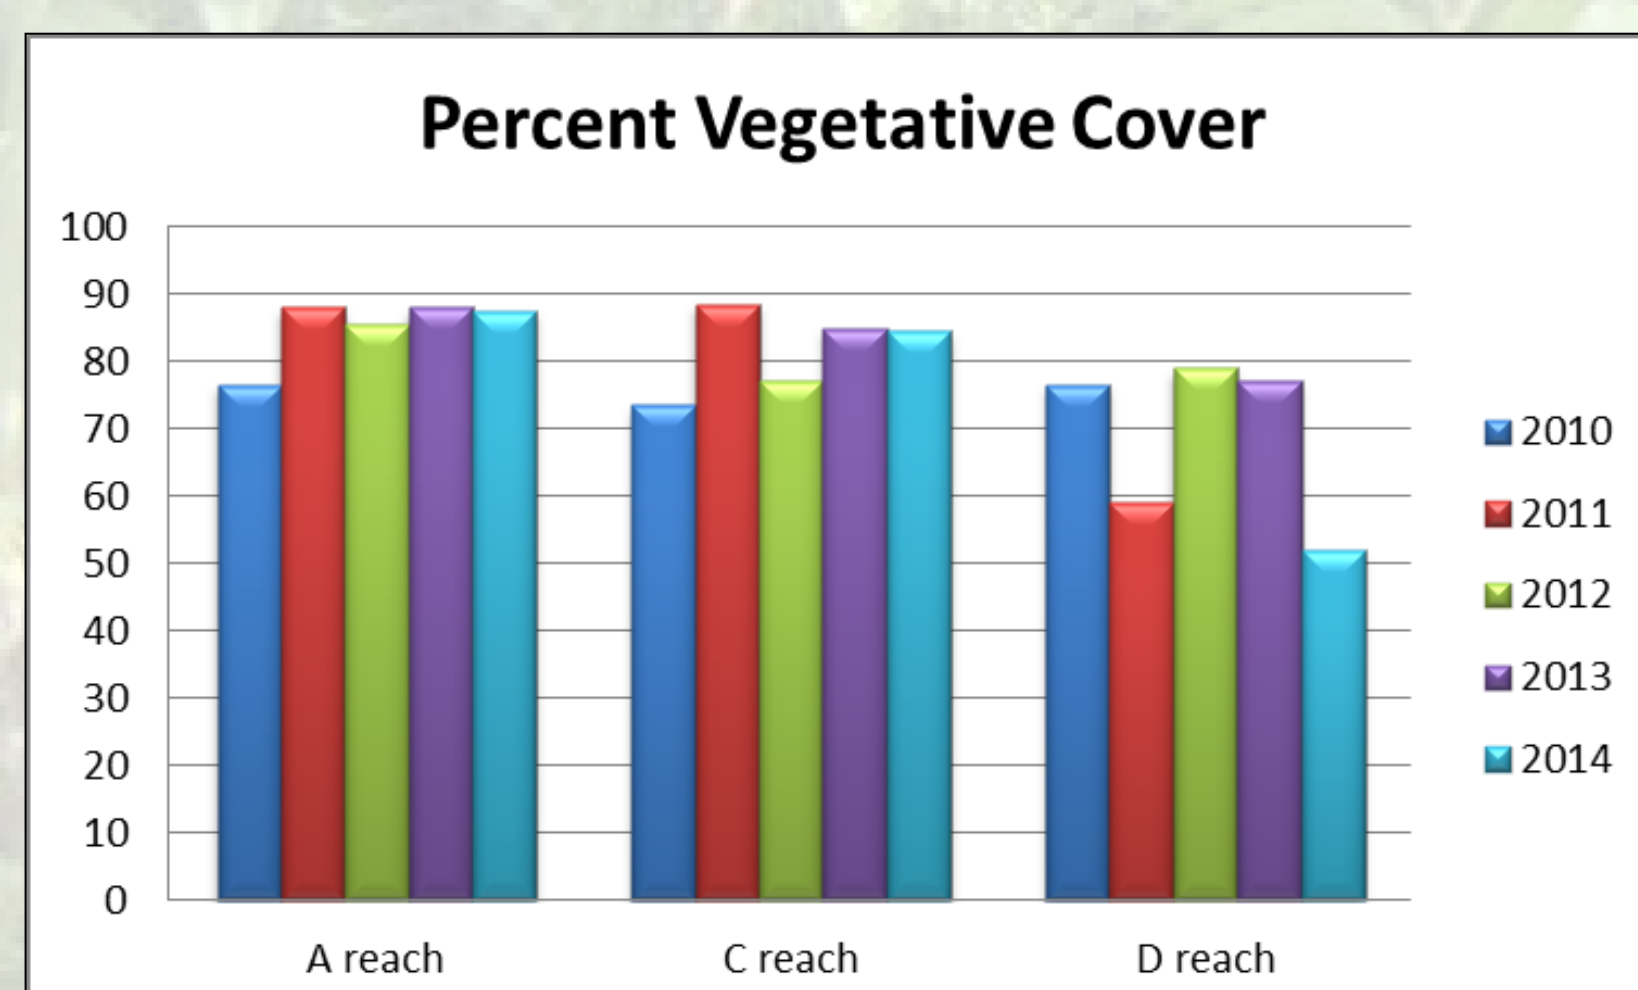
Figure 2 – Changes in the percent vegetative cover along the riparian reaches during the monitoring period.

Along the riparian reaches the vegetative communities have developed and the percent cover (for the most part) has increased since the restoration was established (figures 2-6). Species richness ranged from 7.5 along the A reach to 22 along the C and D reaches. The lower value for species richness along the A reach is reflective of a predominance of tall fescue, *Schedonorus arundinaceus* (Schreb.), and sericea lespedeza, *Lespedeza cuneata* (Dum. Cours.). These species are providing excellent cover as can be seen in figure 3. Vegetation along the D reach has reestablished itself after a devastating flood in 2011. However, the use of herbicide along the Liberty road right-of-way is negatively impacting the reach. During the 2014 sampling soil erosion was observed along the areas where the vegetation is being killed, figure 6.

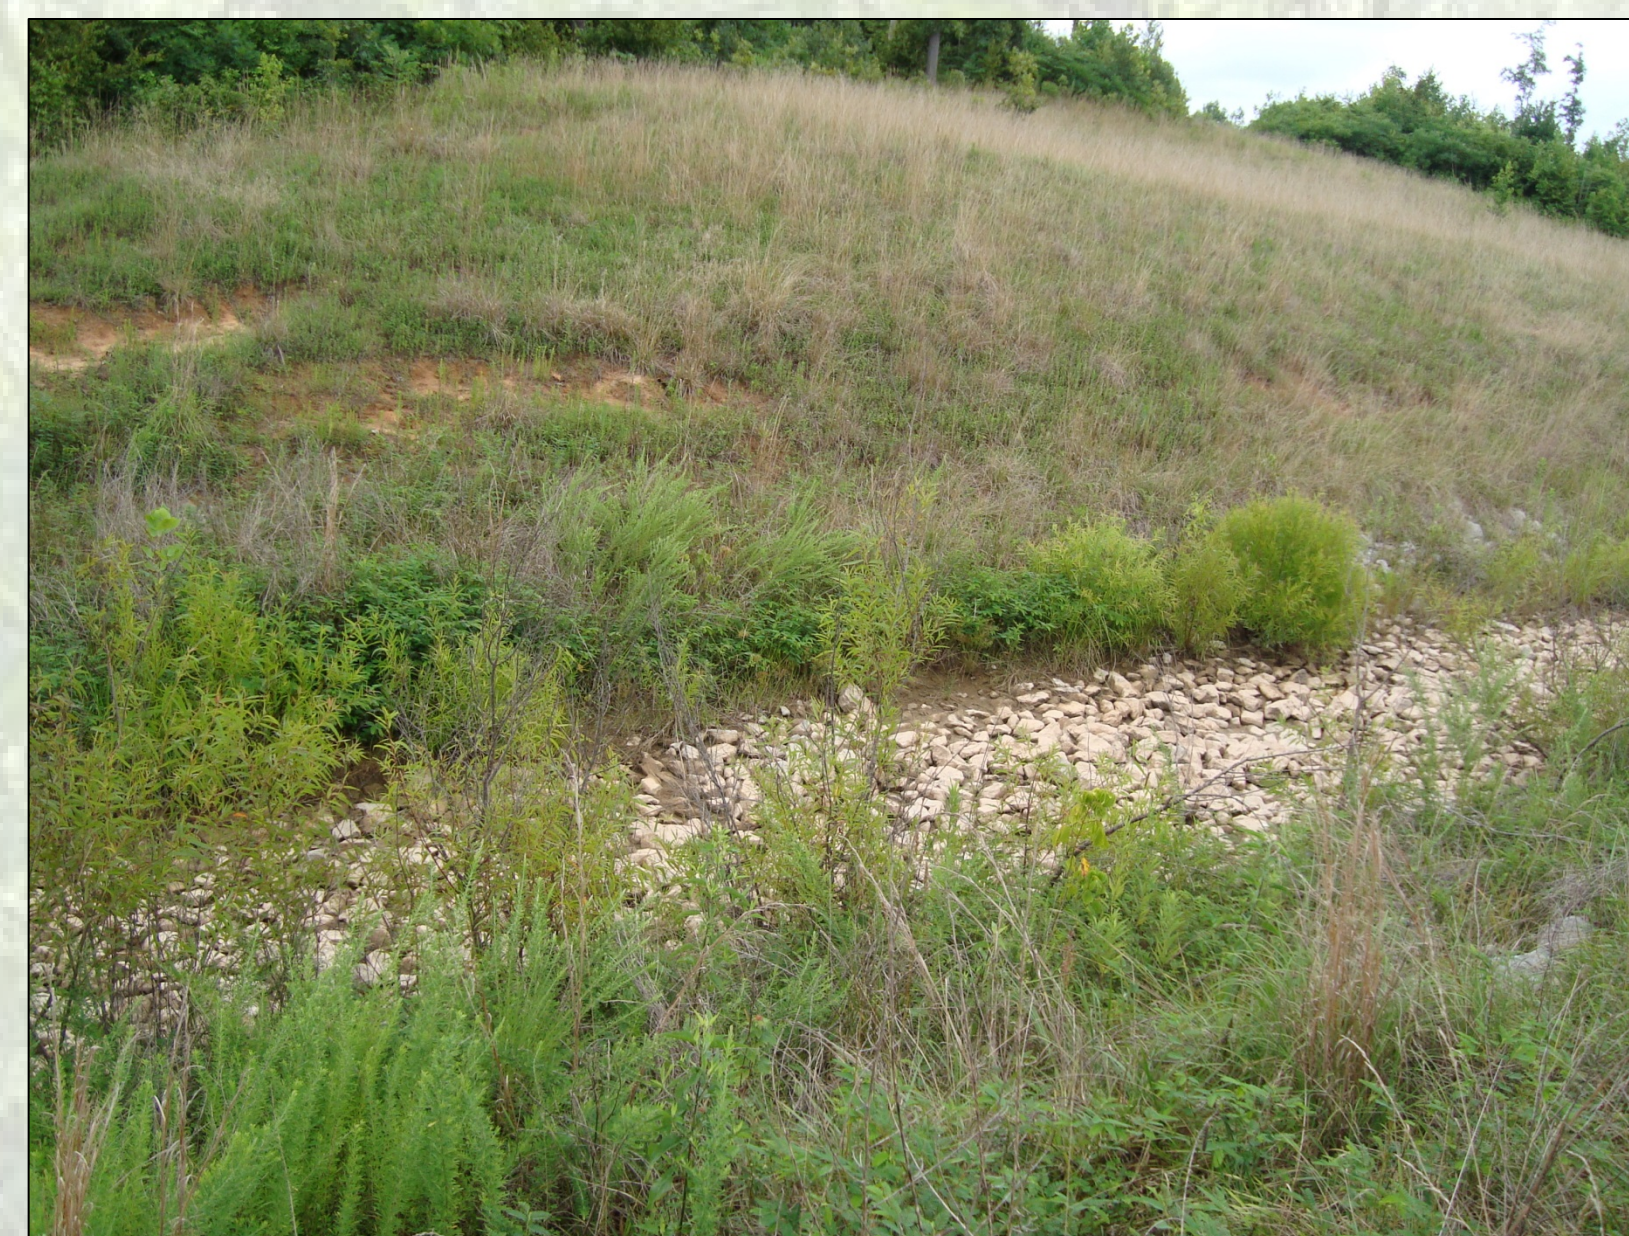
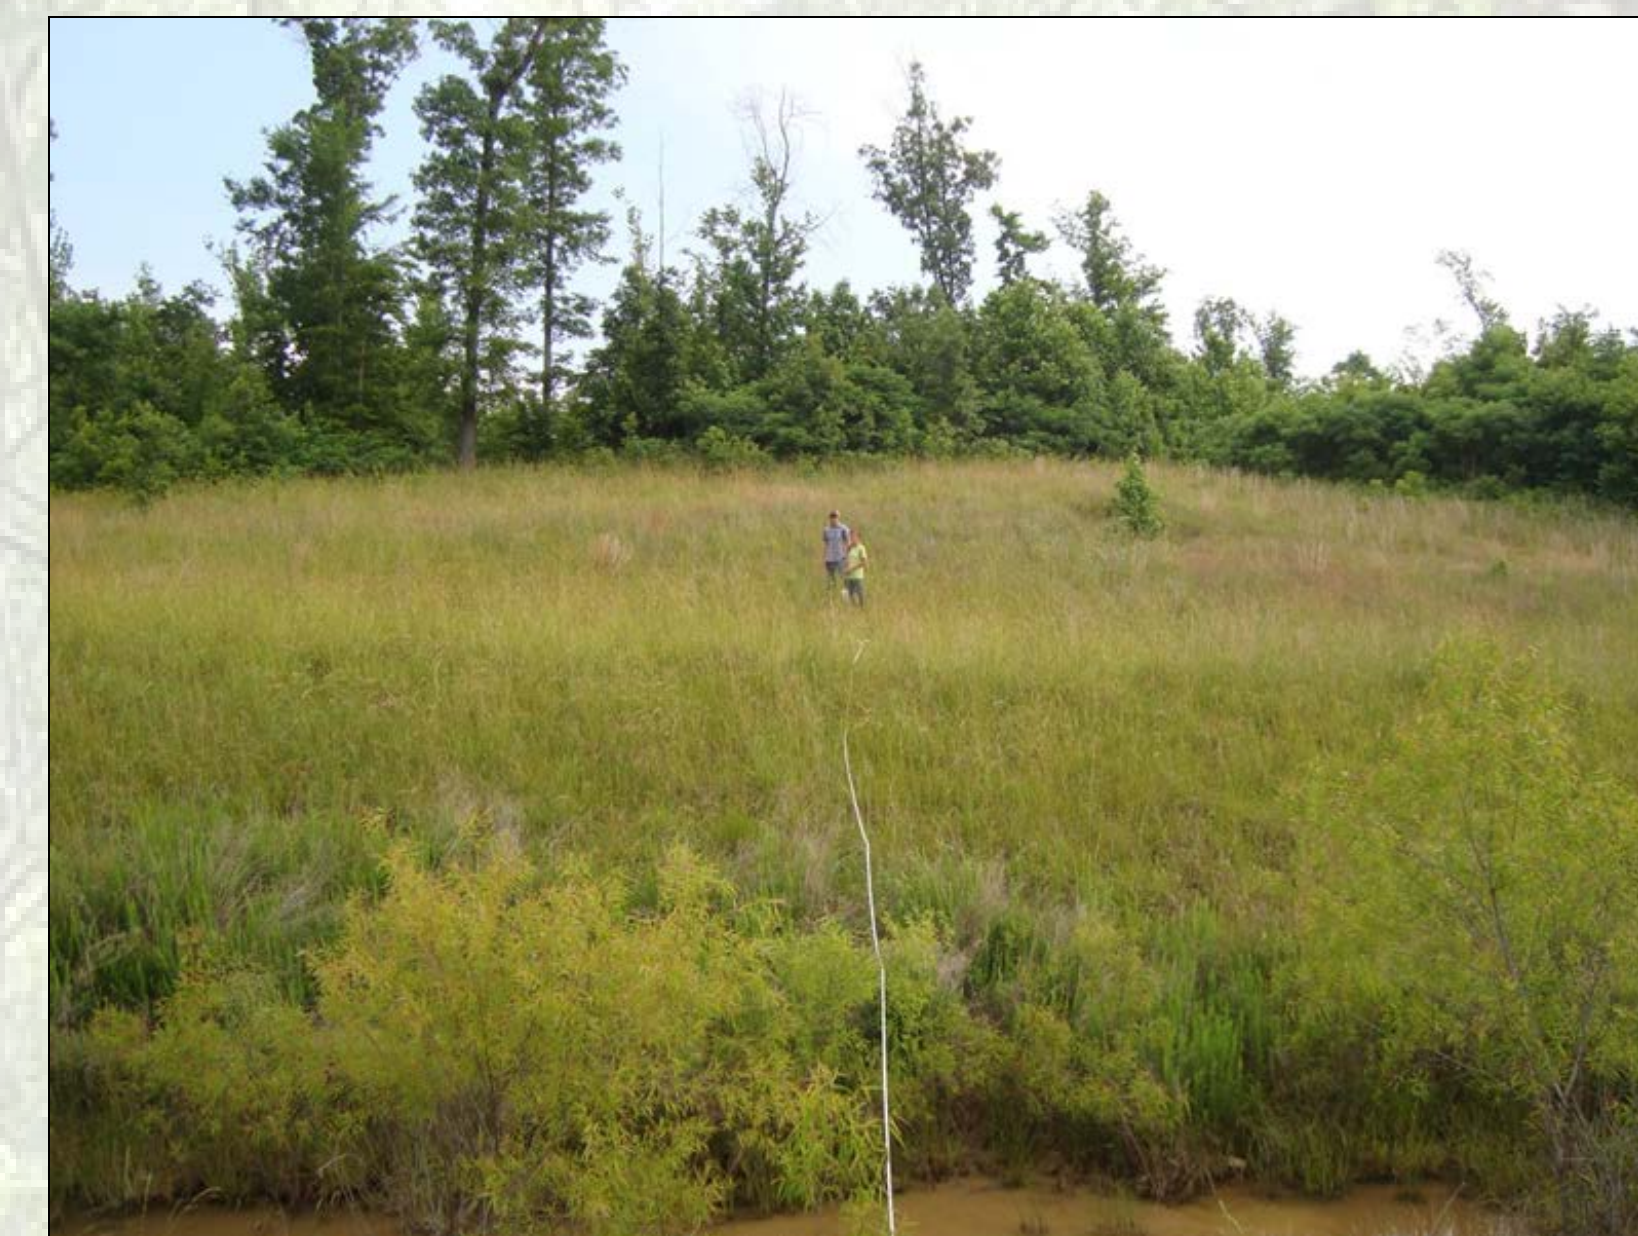
Figure 3 – Photos of reach A taken in 2010 (left) and 2013 (right). The development of the vegetative community along with an increase in overall plant cover is evident.

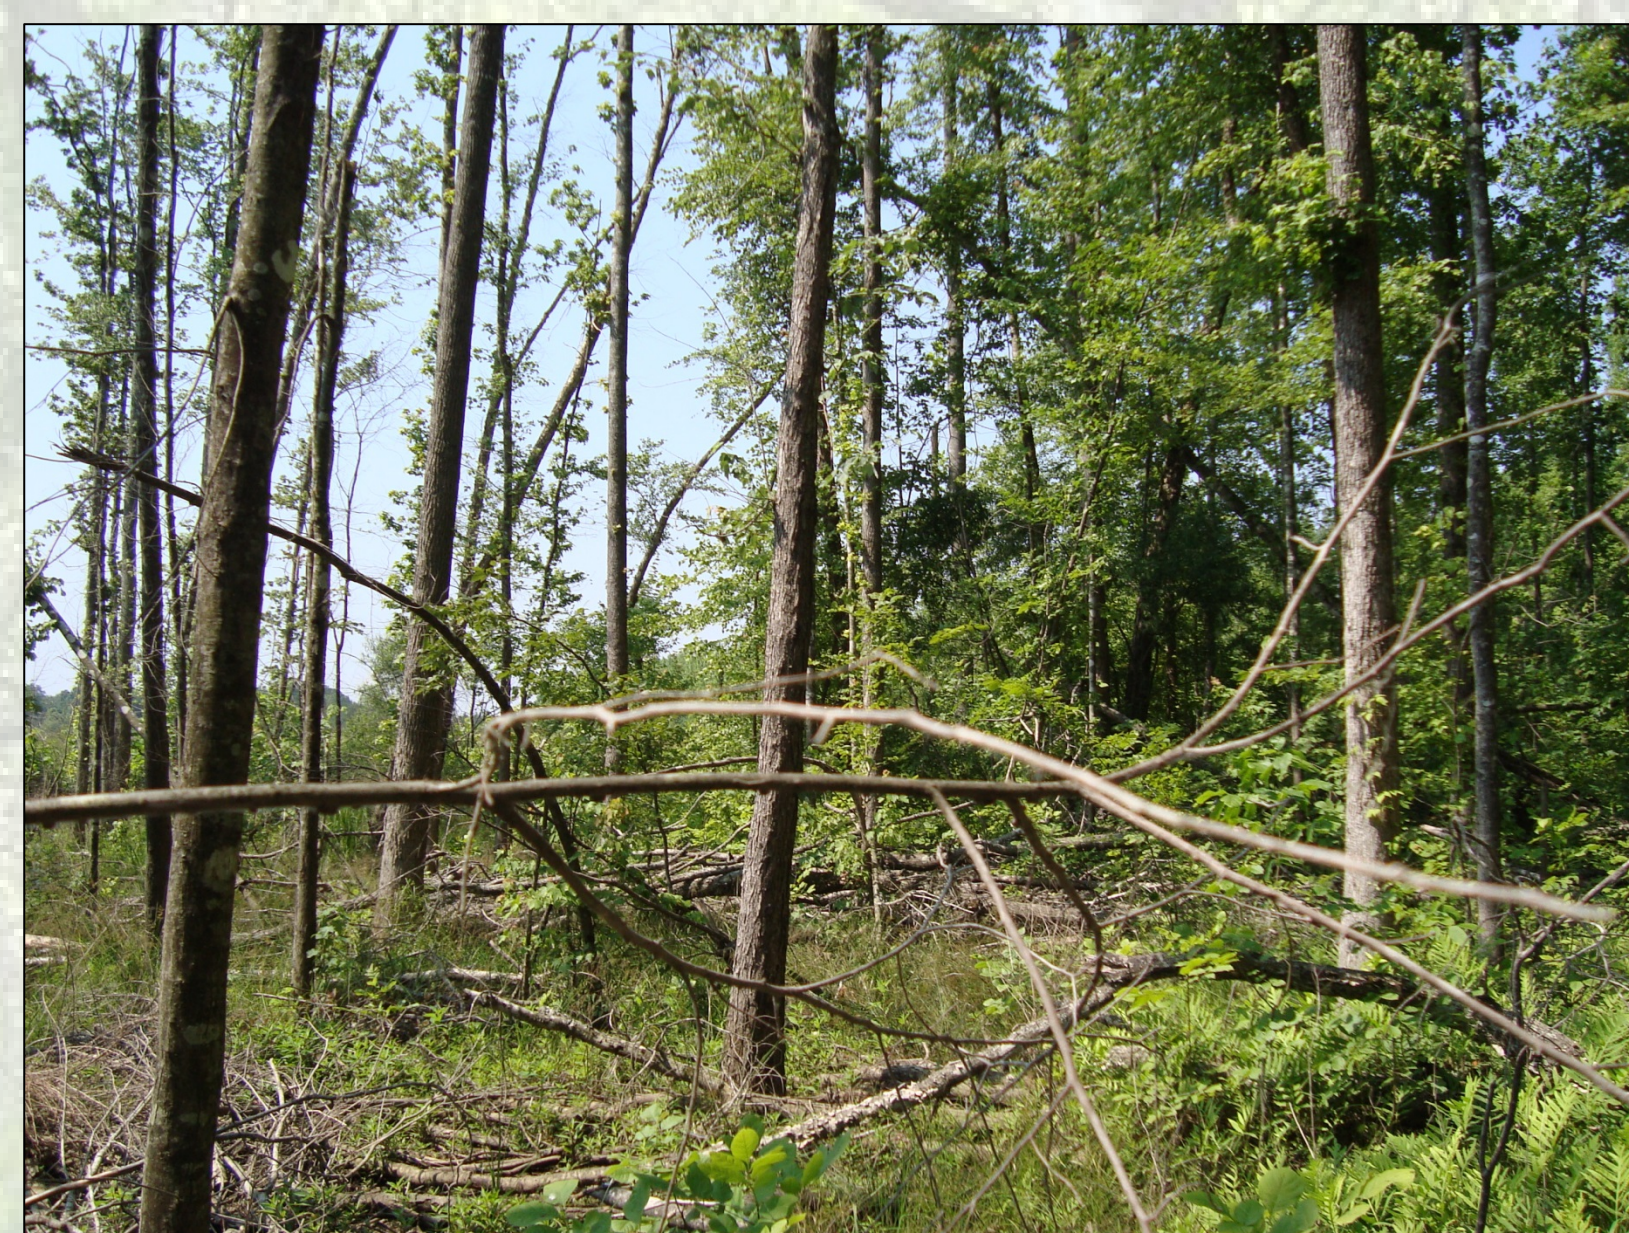
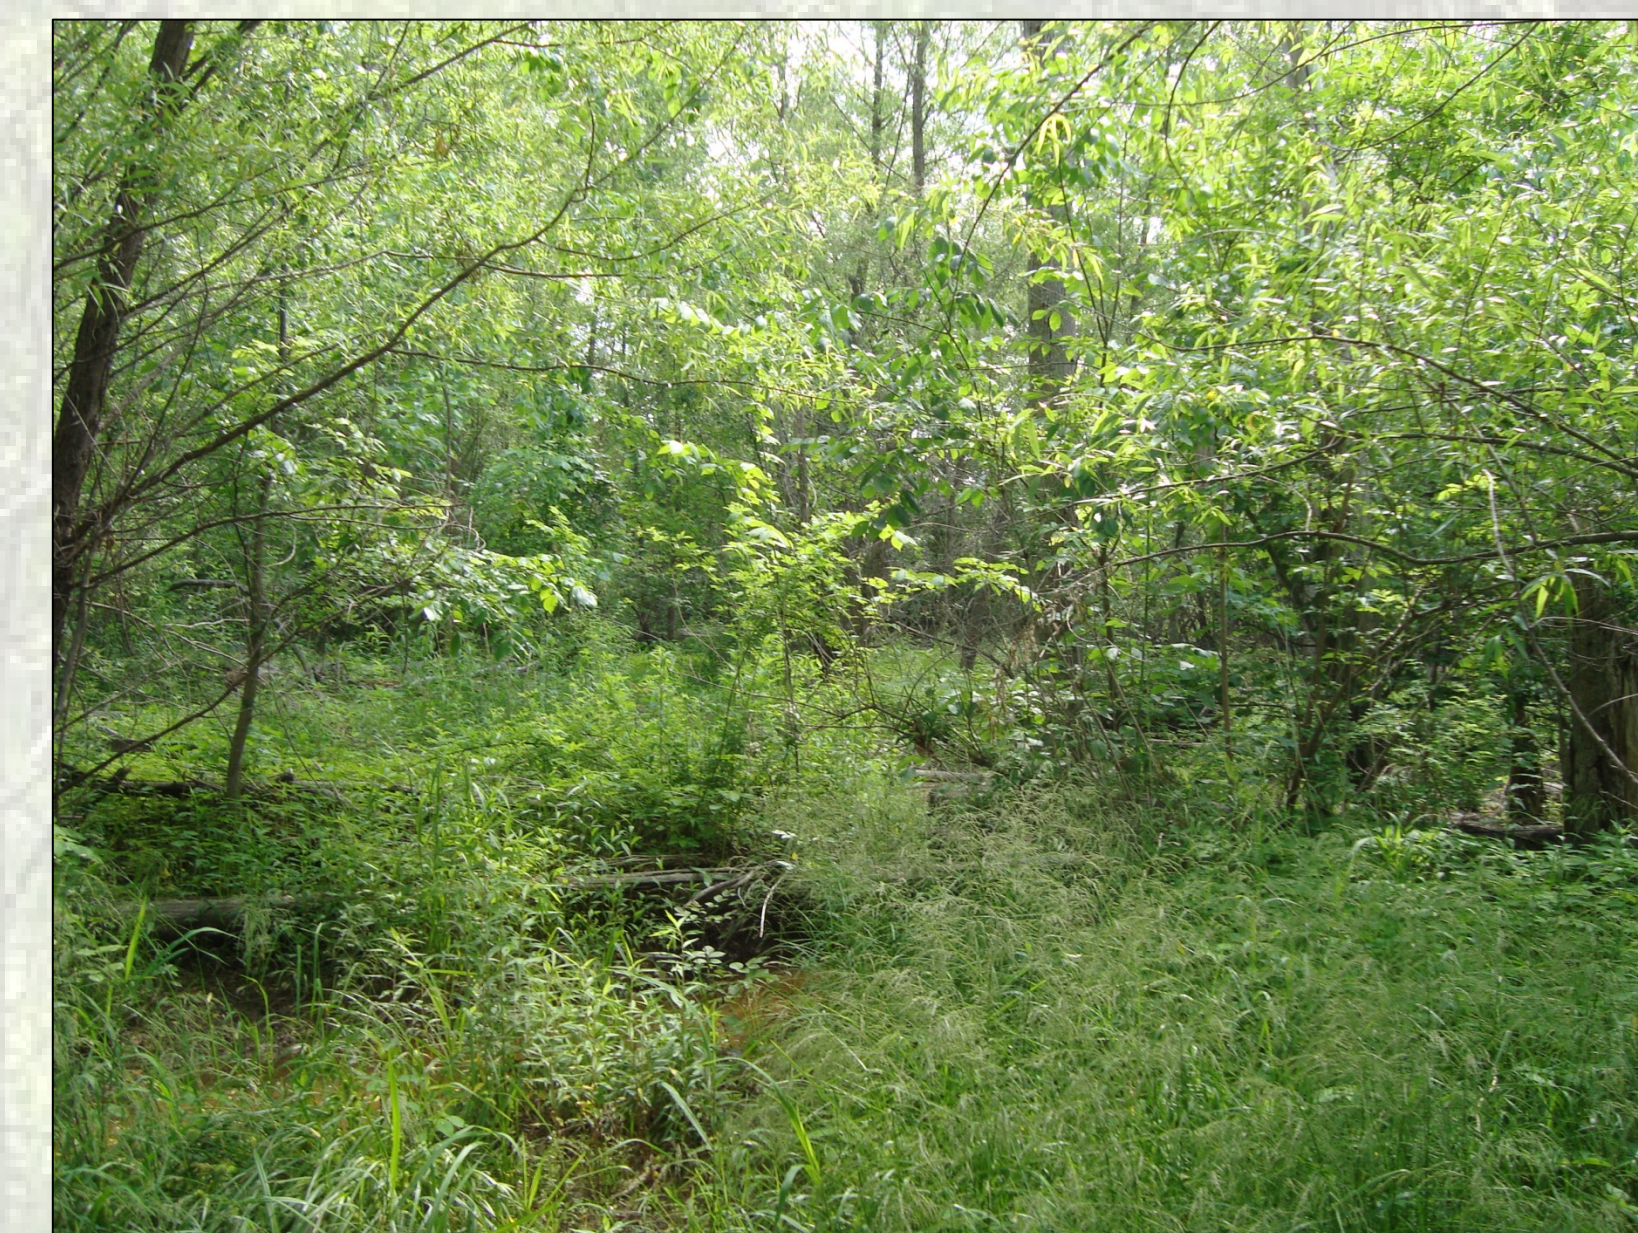
Figure 4 – Photos of the wetland area taken in 2010 (left) and 2014(right). The canopy vegetation has been restored.

The wetland area at the reclamation site is well-established and functional. There are strong indicators for hydrology, soils and plants. The calculated Prevalence Index for the wetland vegetation has decreased from 2.42 at establishment in 2010 to 1.25 in 2014. The entire system is beginning to store carbon as indicated in table 1.

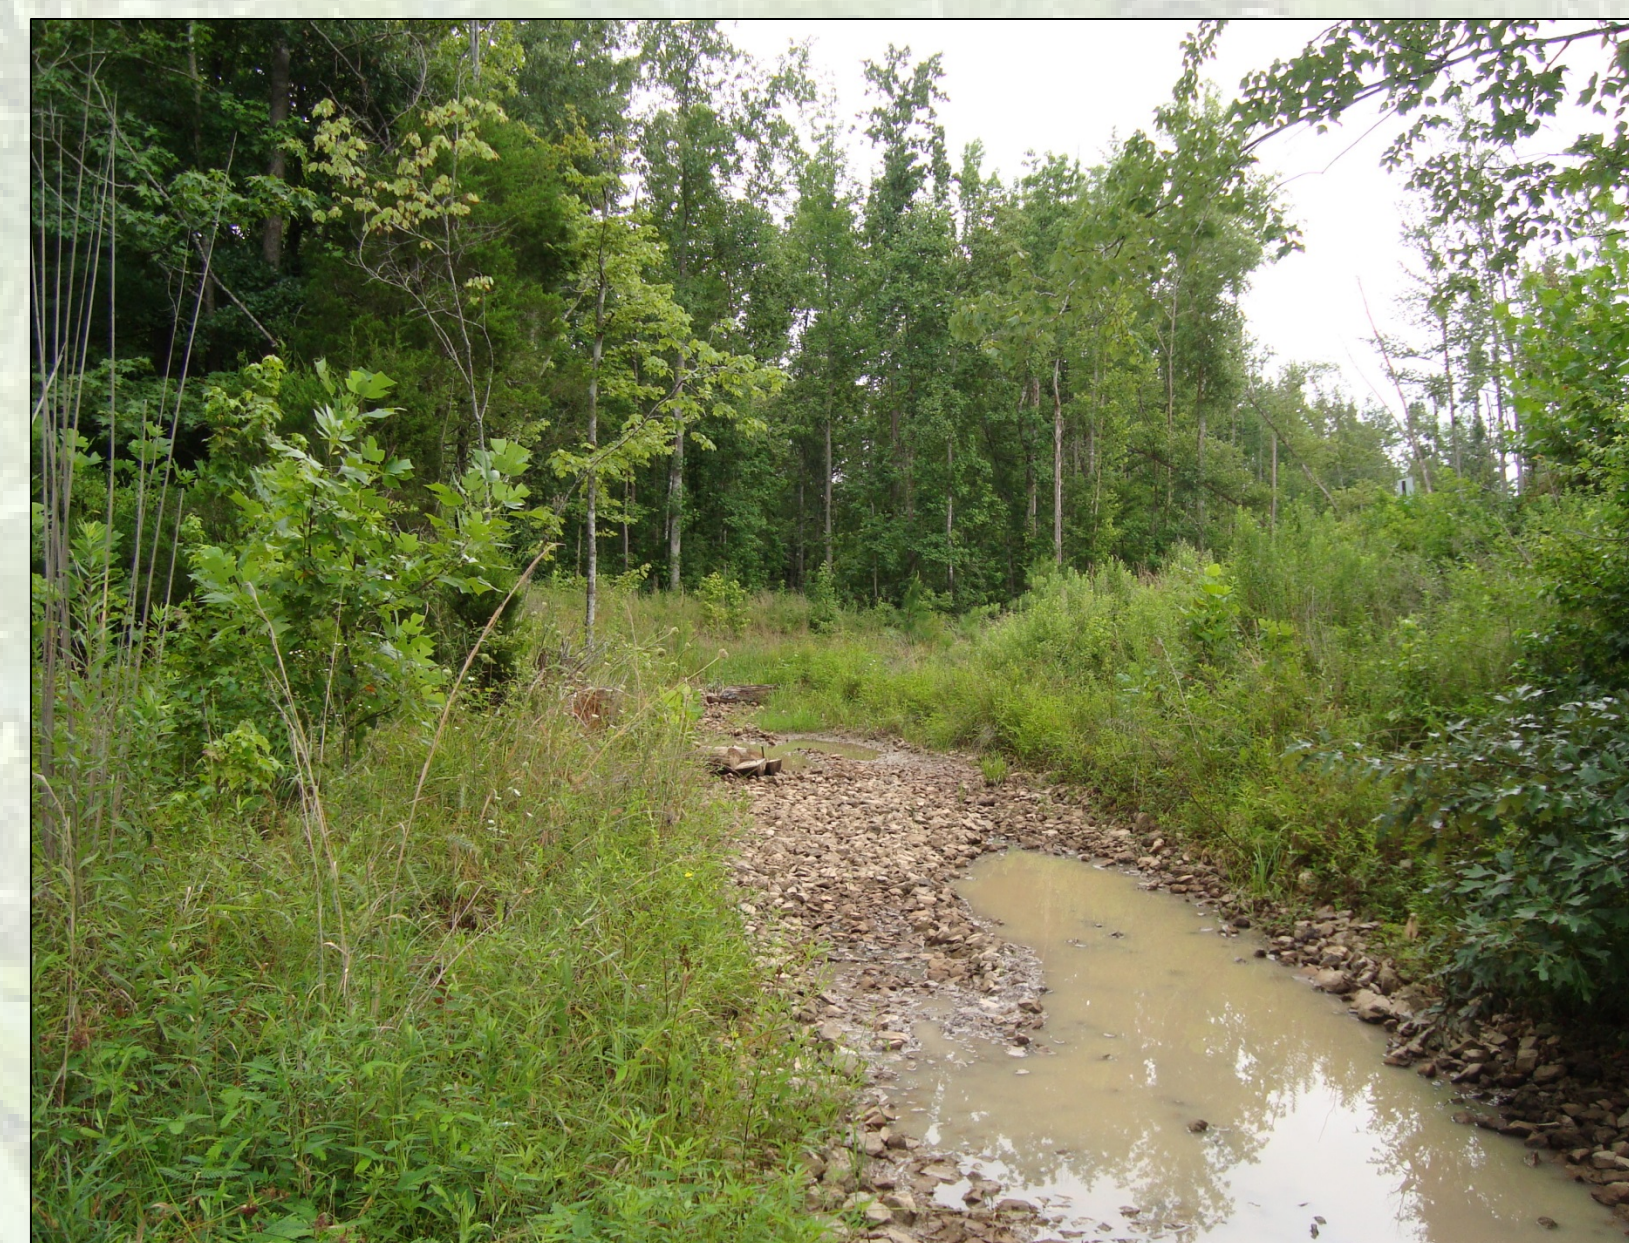
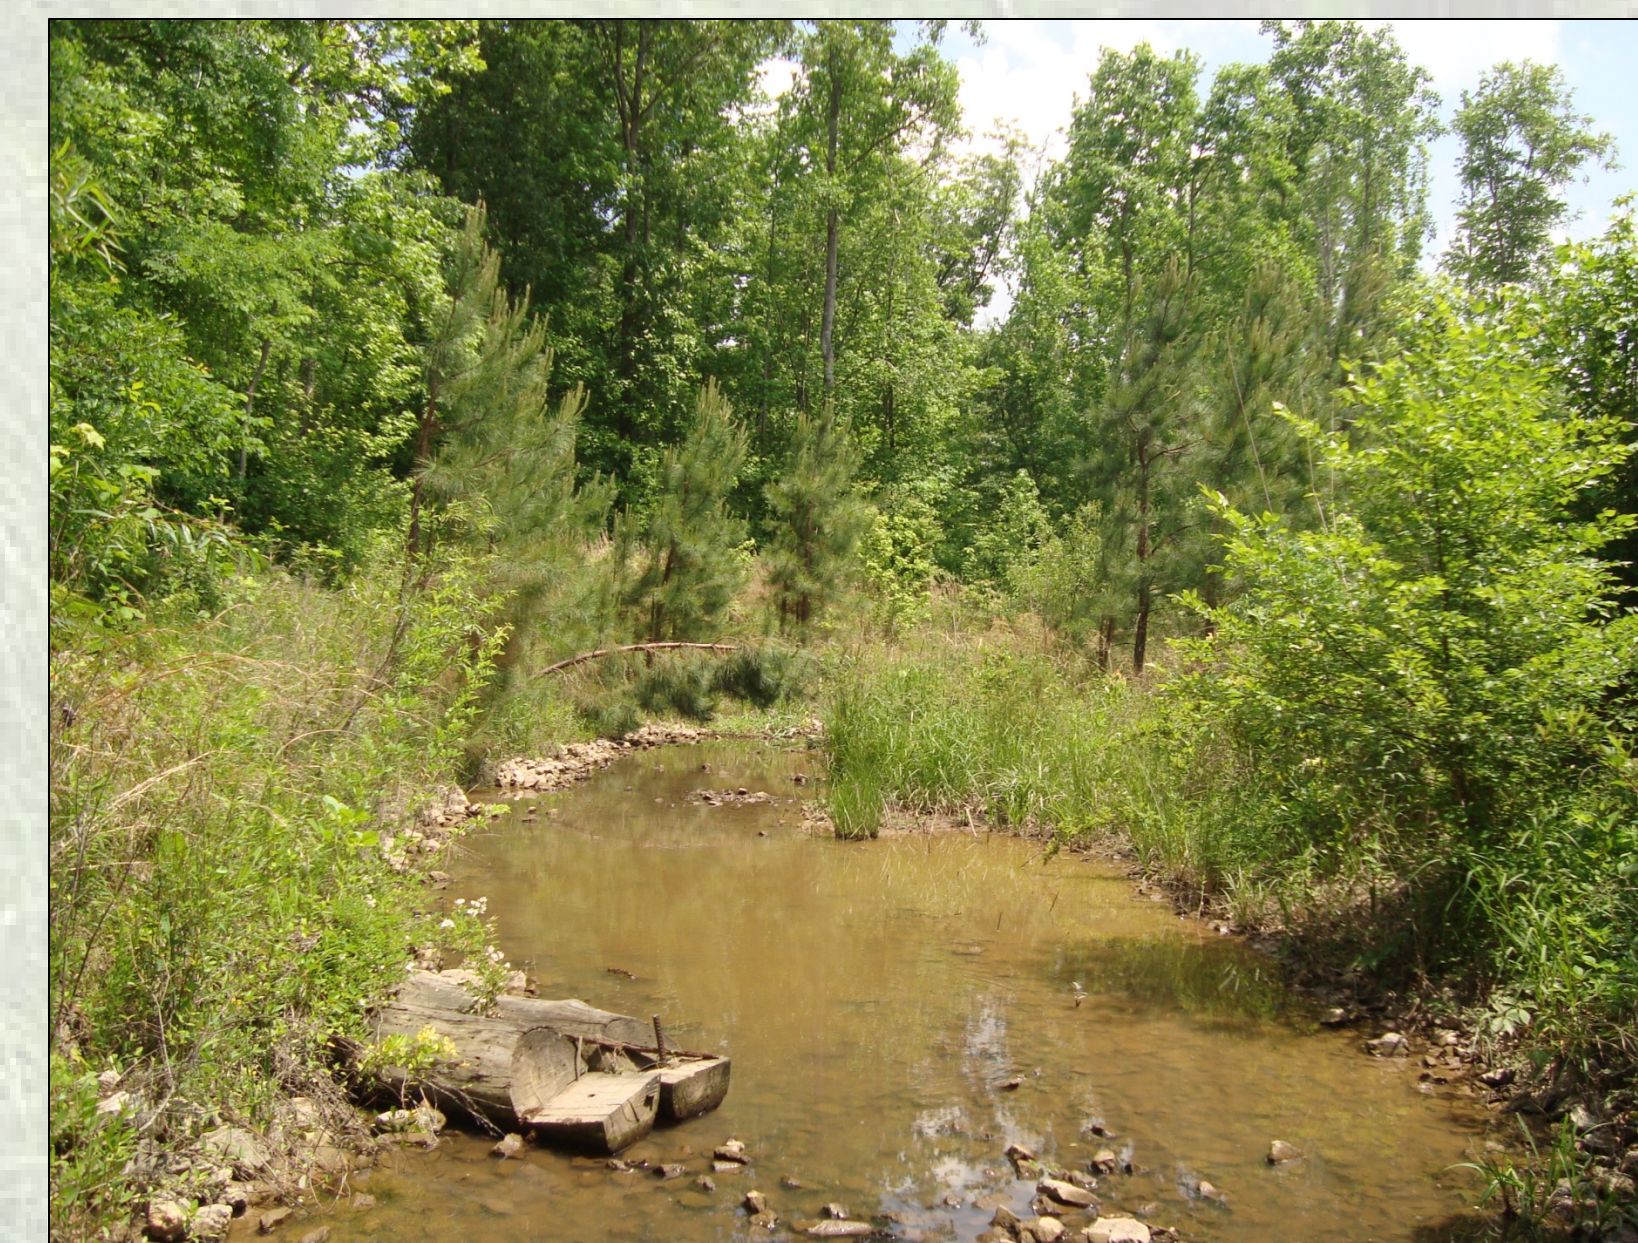
Figure 5 – Photos of reach C taken in 2010 (left) and 2014 (right). Trees along this reach are becoming well established.

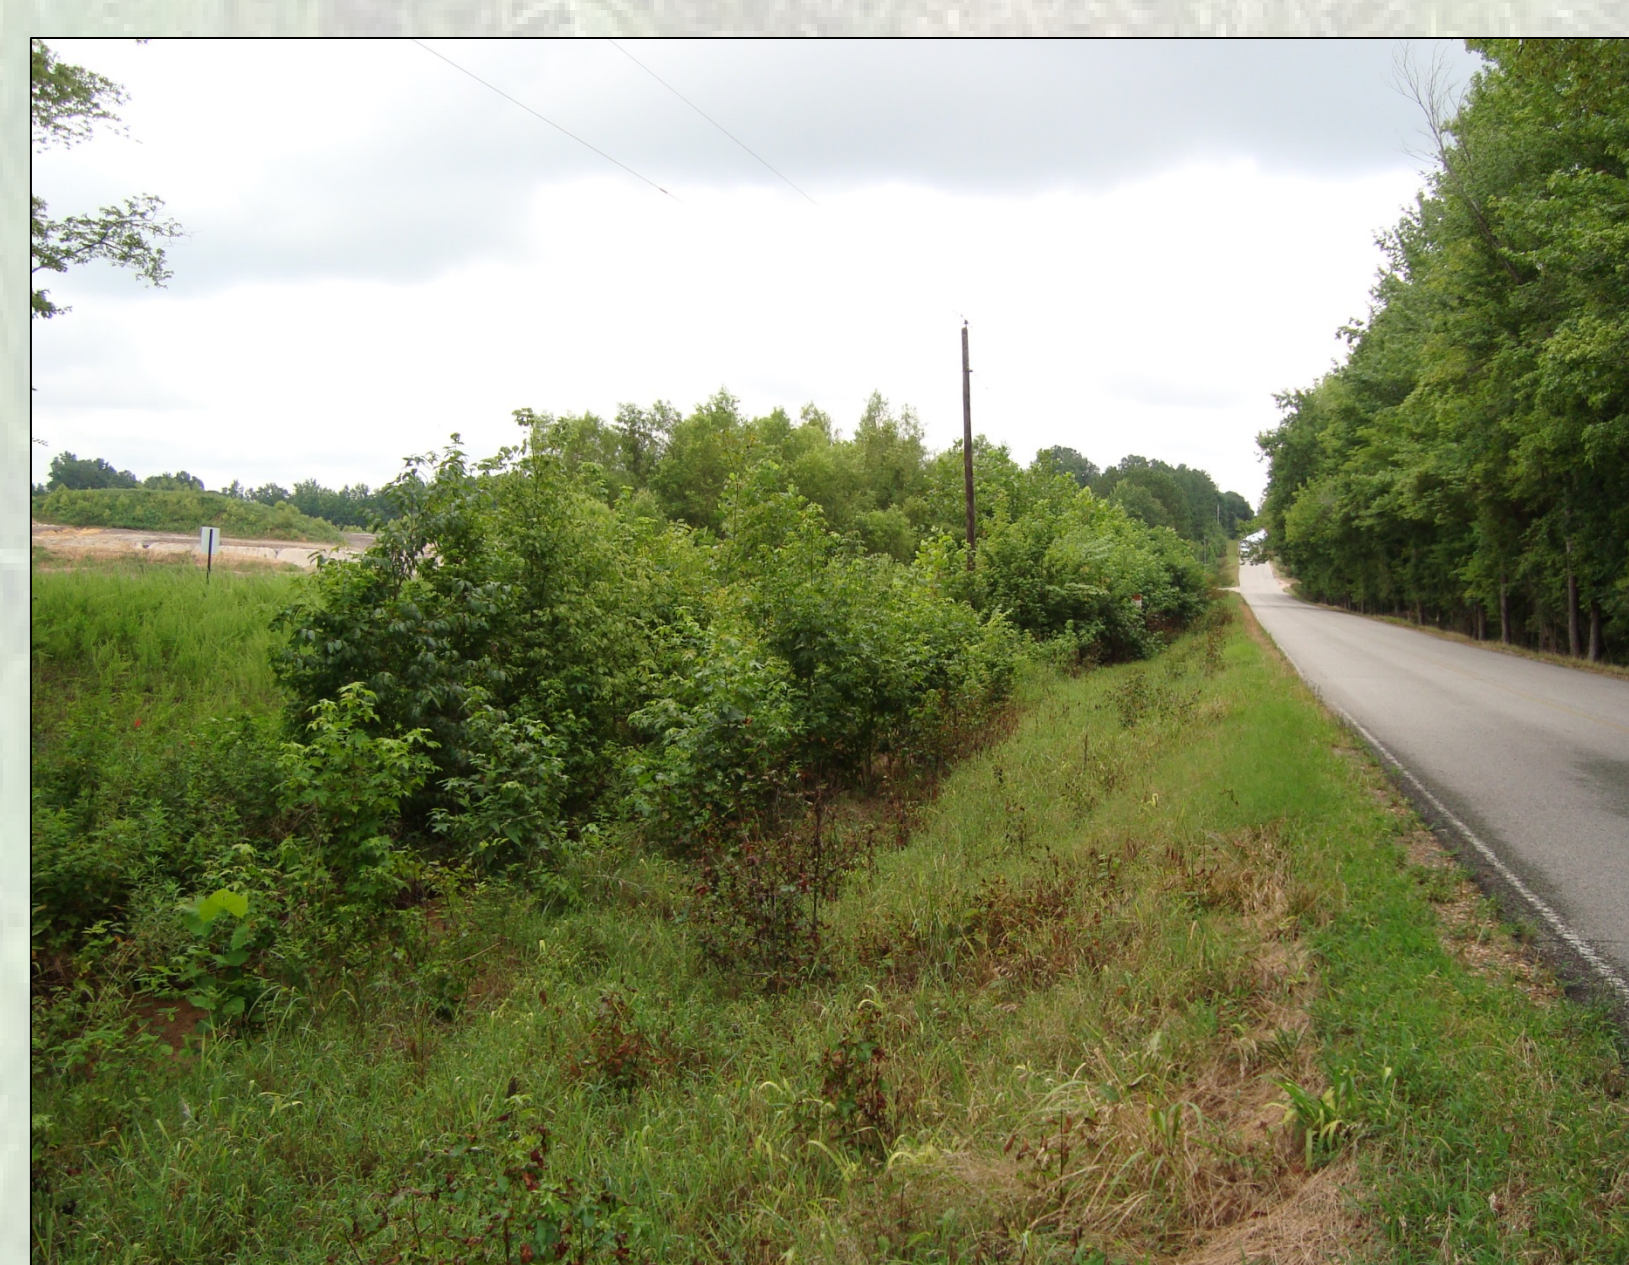
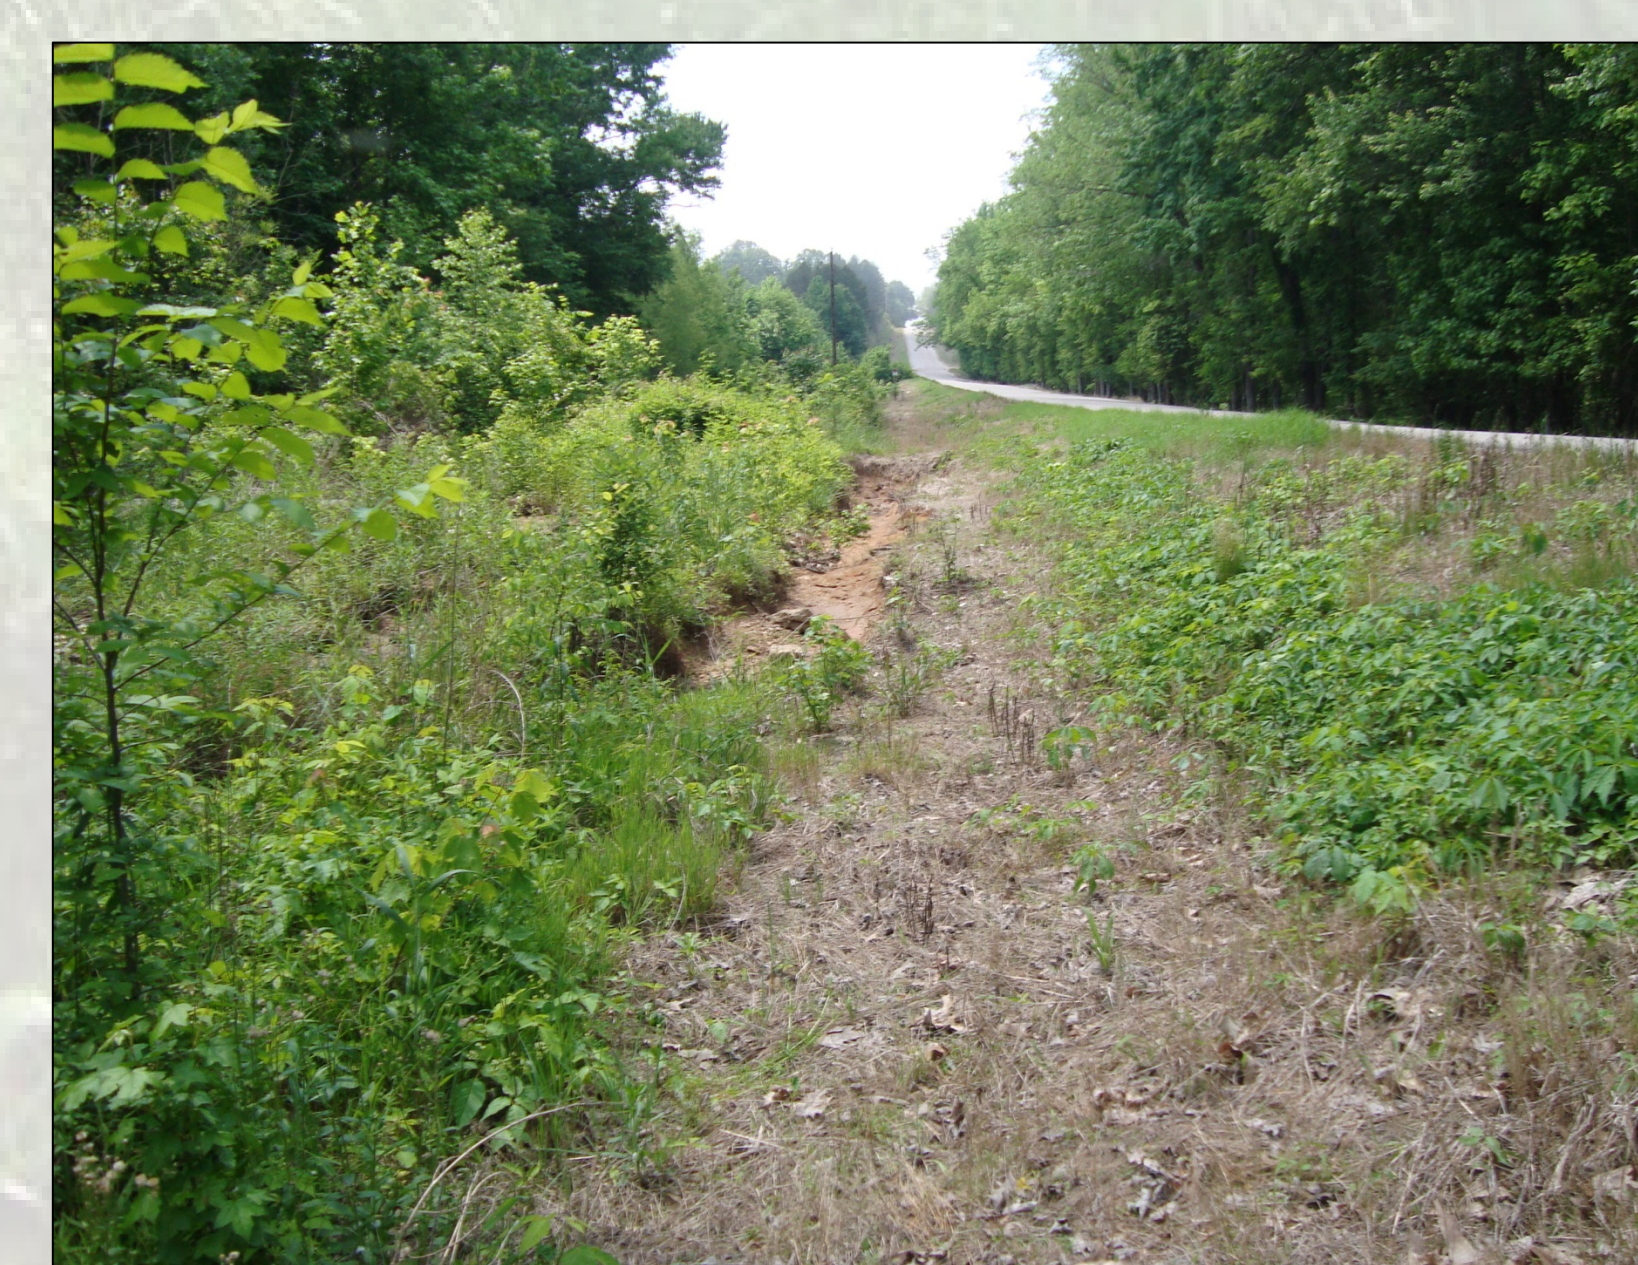
Figure 6 – Photos of reach D taken in 2010 (left) and 2014 (right). Herbicide use along the Liberty road right-of-way is limiting the riparian vegetation along this reach.

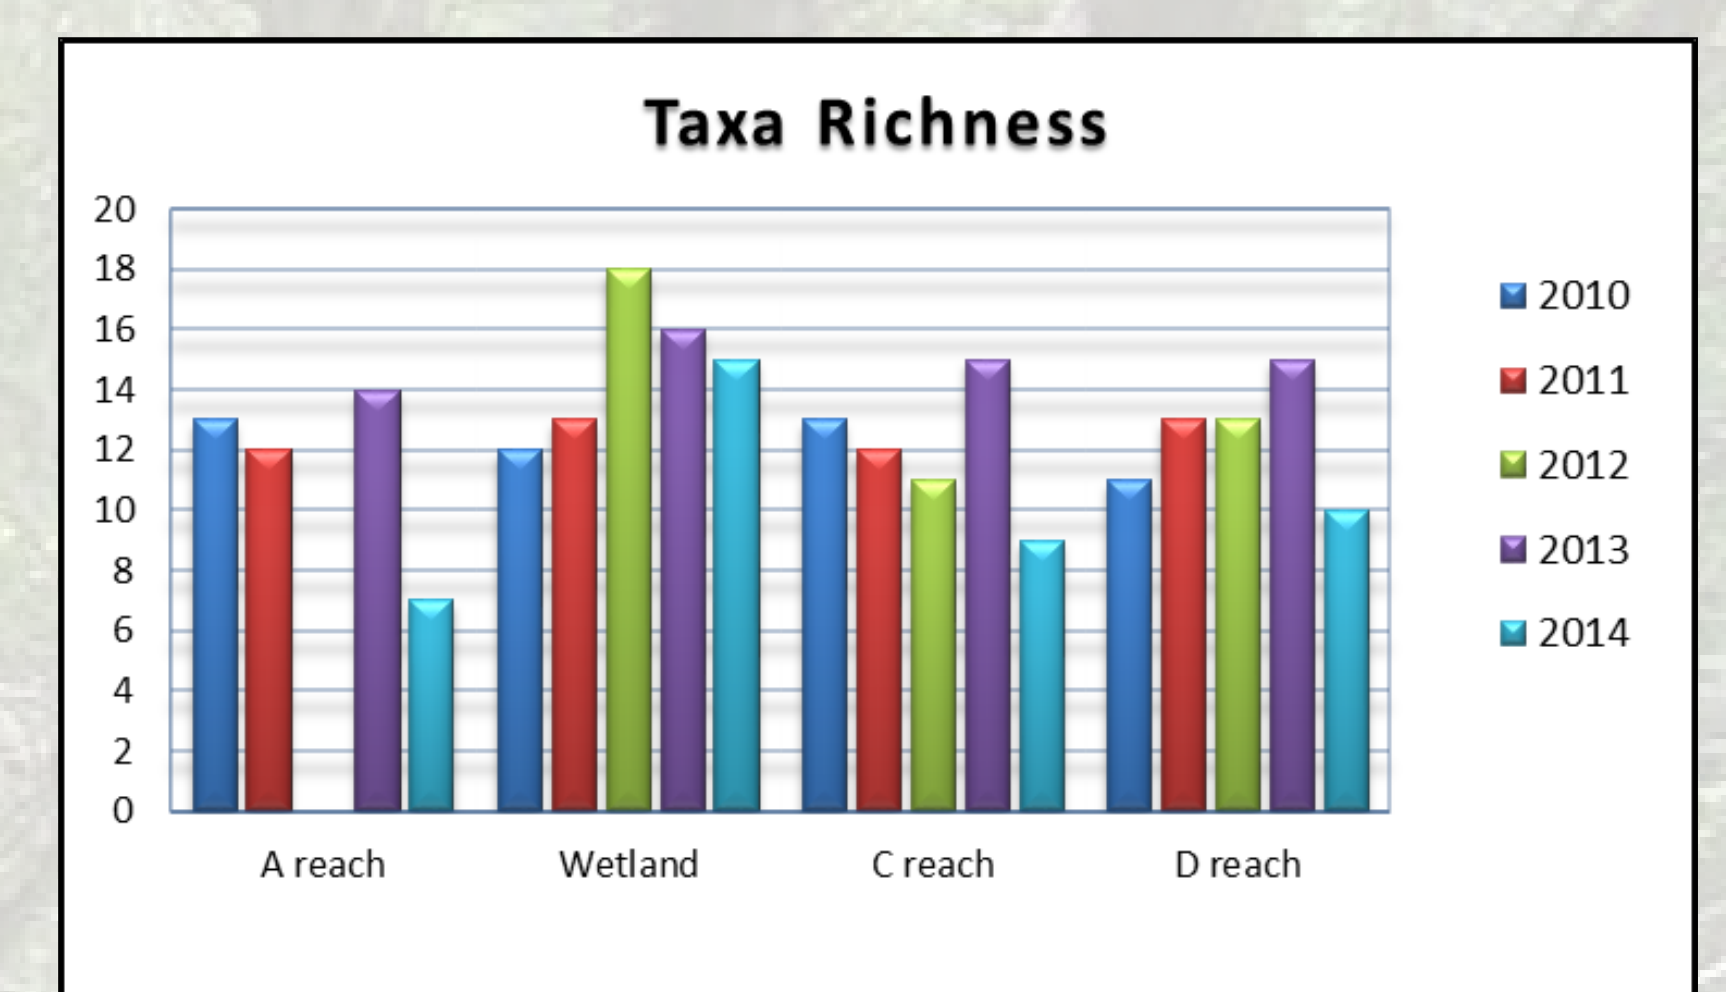
Figure 7 – Changes in macroinvertebrate populations along each of the reaches during the monitoring period.

Although taxa richness of aquatic macroinvertebrates was relatively low (figure 7), this was likely a reflection of the limited available habitats. During the summer months, reach A was dry in some years, and the other reaches experienced very low water levels. The presence of somewhat sensitive taxa like mayflies and caddisflies suggested that water quality was good when water levels were high enough to provide appropriate habitat. The wetland habitat consistently supported the most diverse community of aquatic macroinvertebrates. We believe this to be a result of a more consistent availability of adequate aquatic habitat. The aquatic macroinvertebrate community in this system was judged to be normal given the physical features of the stream and the ephemeral nature of specific reaches.
