Heavy Metal Contamination in New Mexico Soils after 2015 Gold King Mine Spill

Sam Fullen, Department of Plant and Environmental Sciences, New Mexico State University
Advisors: Dr Kevin Lombard, Dr April Ulery, Dr. Lois Stanford, and Barbara Hunter

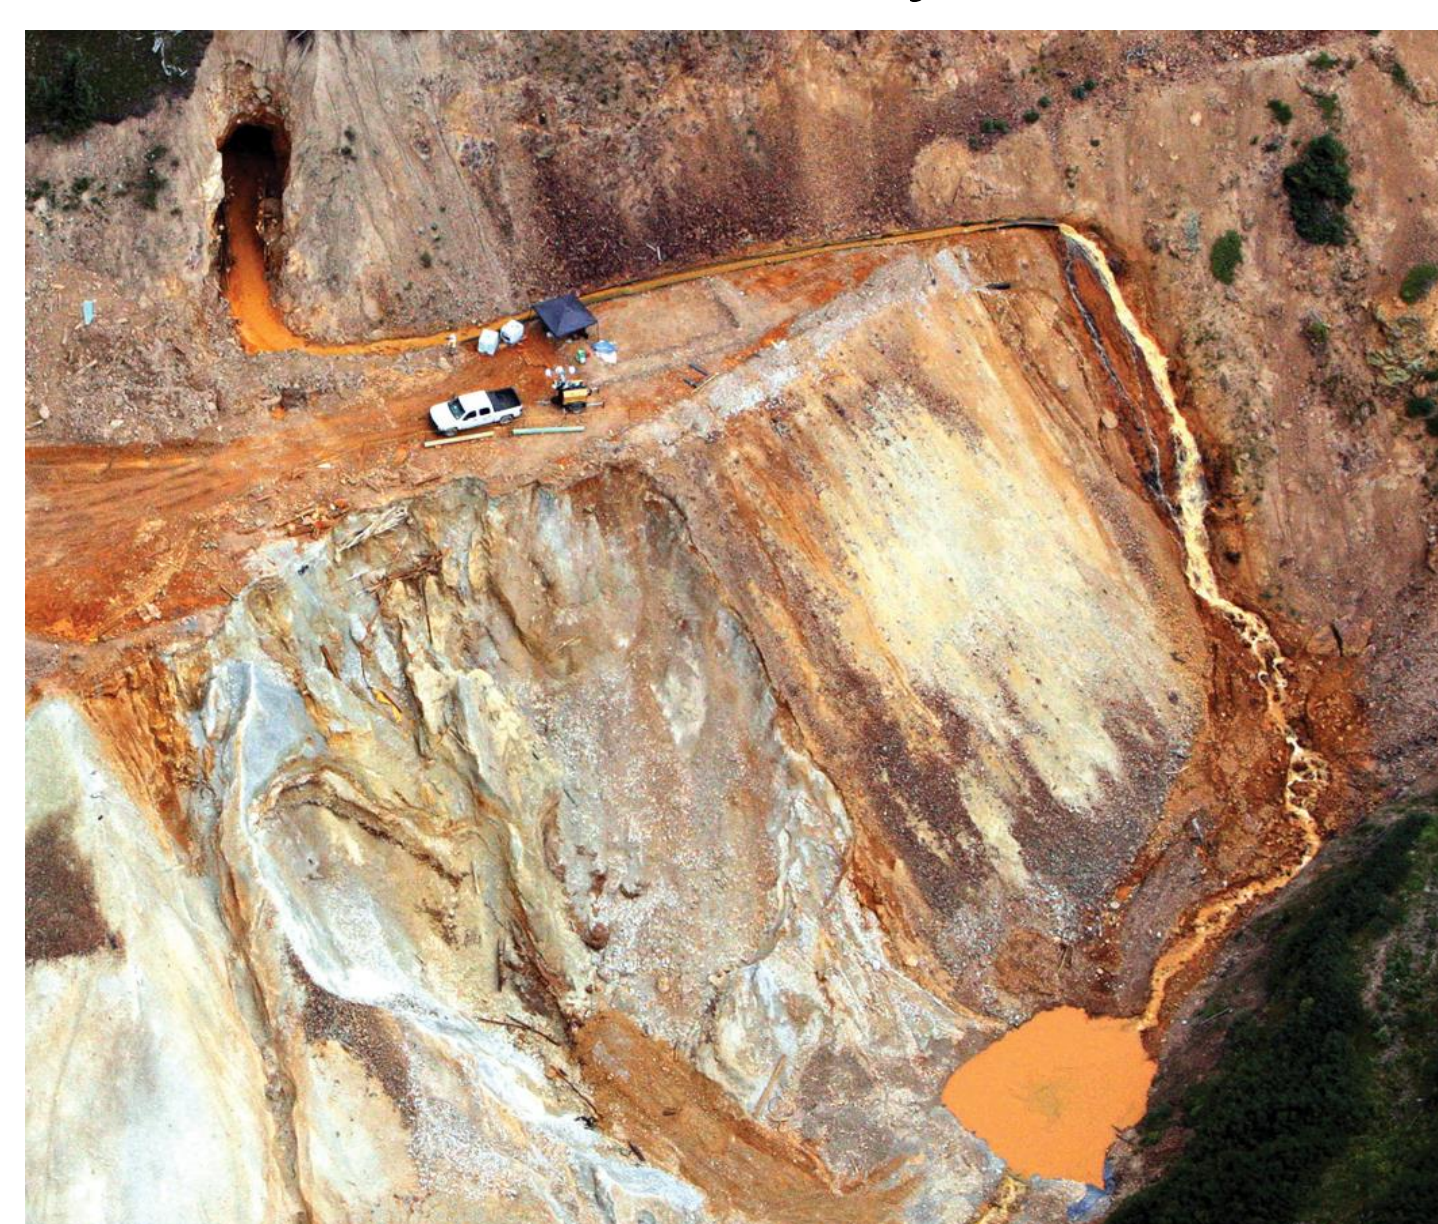
Figure 1: A picture showing the waste flow nearly two weeks after the initial blowout at the Gold King Mine (right). Photo by Geoff Liesik of Desert News: <http://www.hcn.org/issues/48.7/silverton-ns-gold-king-reckoning/silverton-animas-goldking-jpg/image>

- On August 5, 2015, Environmental Protection Agency (EPA) contractors accidentally destroy a plug at the entrance to the Gold King Mine (GKM)
- Approximately 3,000,000 gallons of acid mine waste water containing elevated heavy metals are released into Cement Creek, a tributary of the Animas River

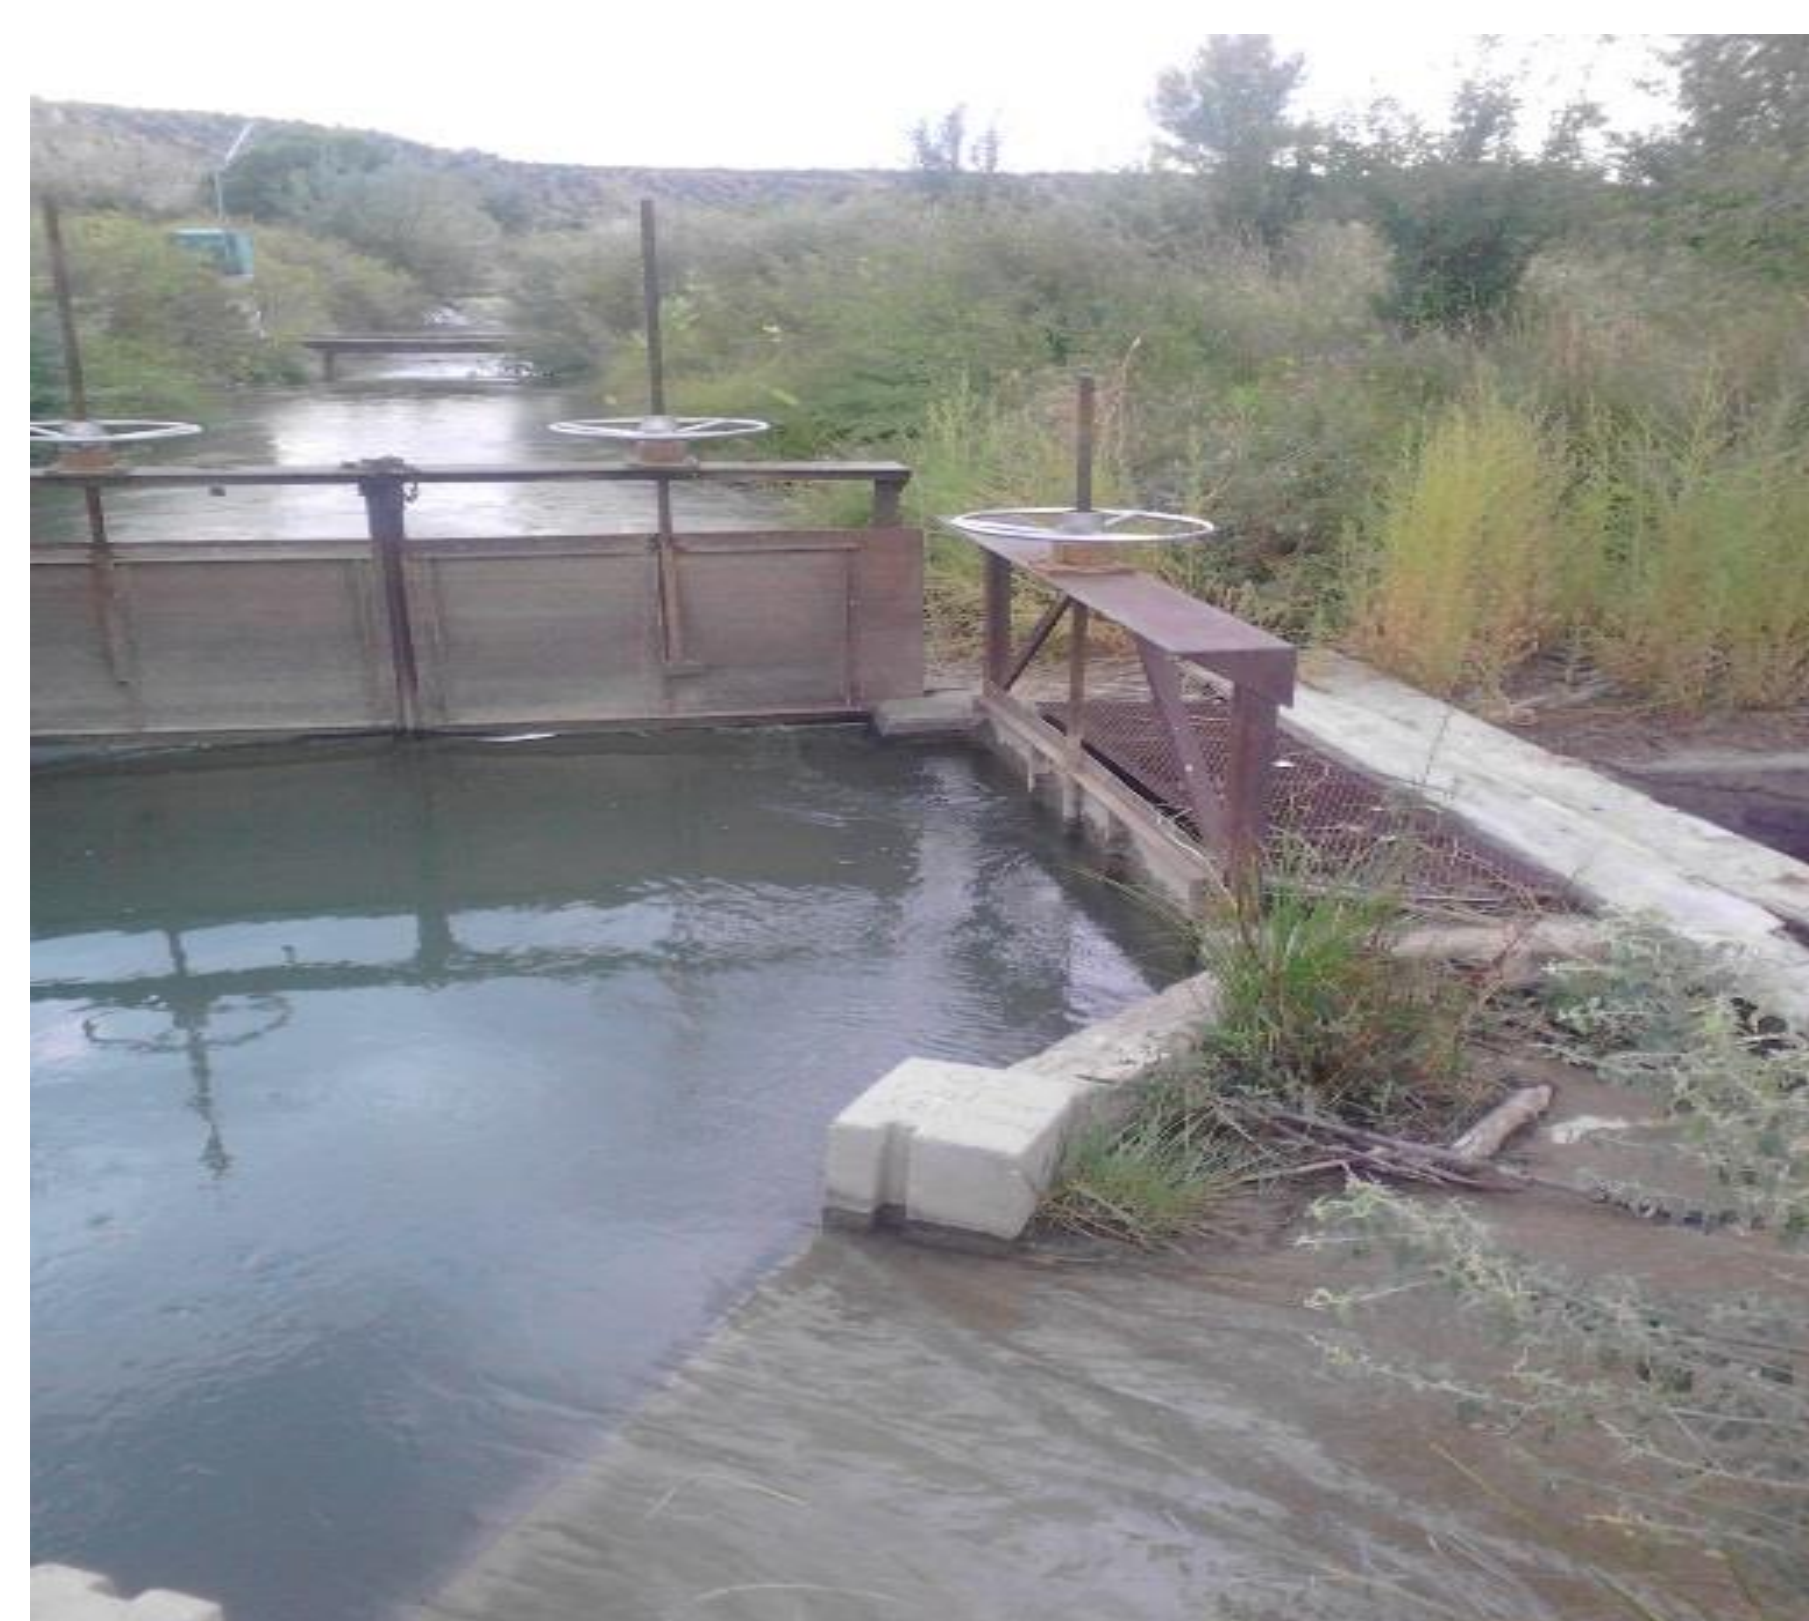
Fig 4: Animas/San Juan River water diverted for agricultural irrigation of forage crops, grains, high value horticultural crops. These irrigation ditches also feed into subsistence farming plots (left). Photo by K.A. Lombard

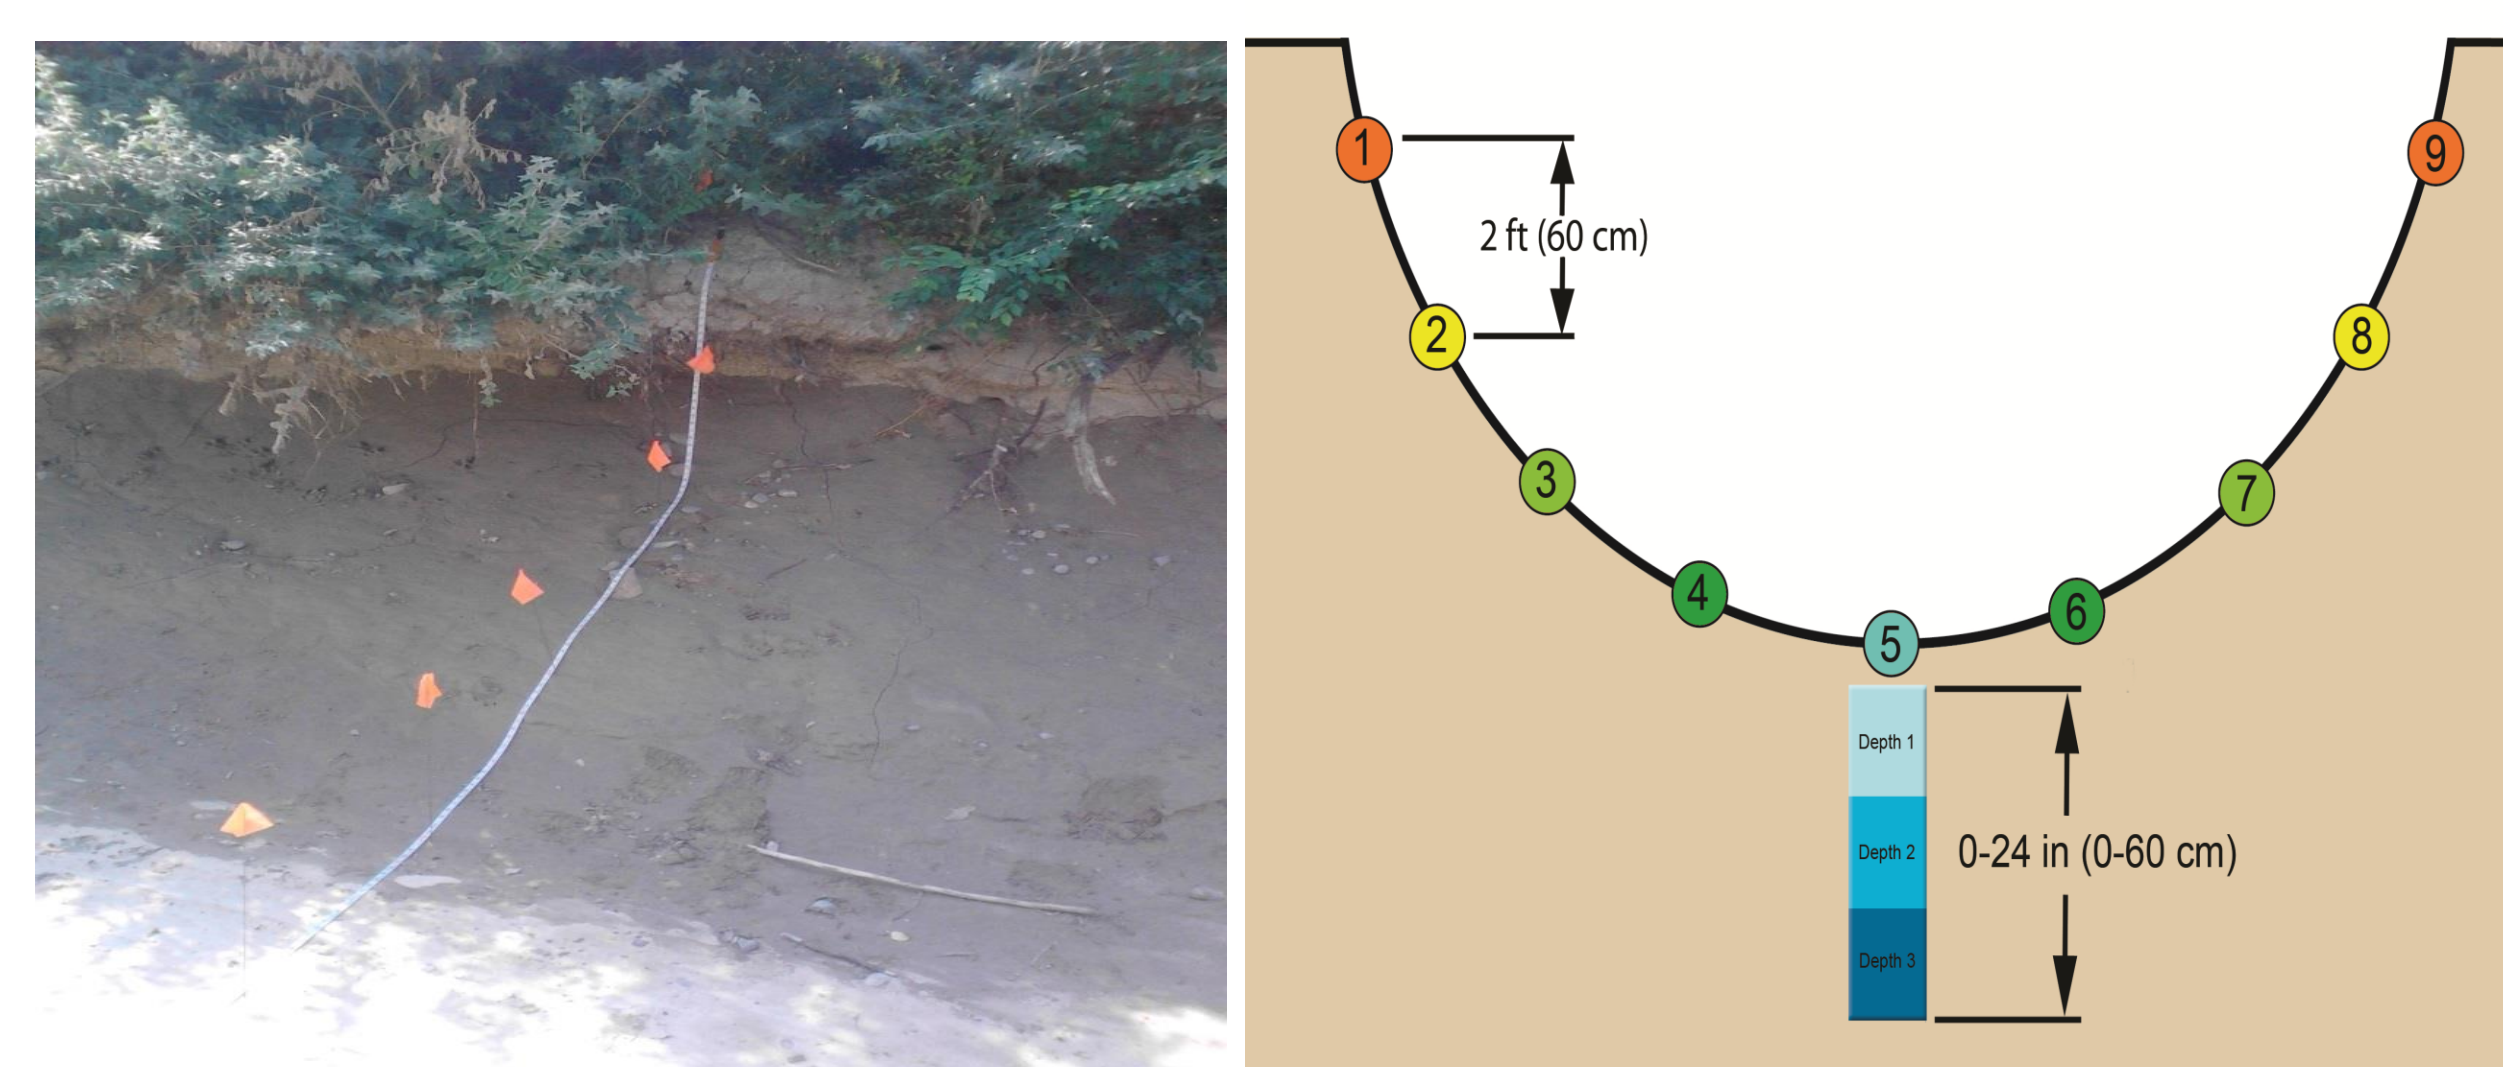
Fig 5: Sampling technique: Photo and figure by Dr. K.A. Lombard

- Irrigation ditches closed before the waste plume passed. The soil in these ditches was sampled in 13 irrigation ditches and provide "baseline" levels of metals.
- Soil samples were collected at three depths along transects perpendicular to ditches using EPA method 5035 (Figure 5)
- Soils were air dried, sieved and acid digested using EPA methods 3051A, followed by ICP-OES analysis (EPA 200.7)
- Paired t test were conducted for metal concentrations between parallel ditch position within one ditch to one depth.

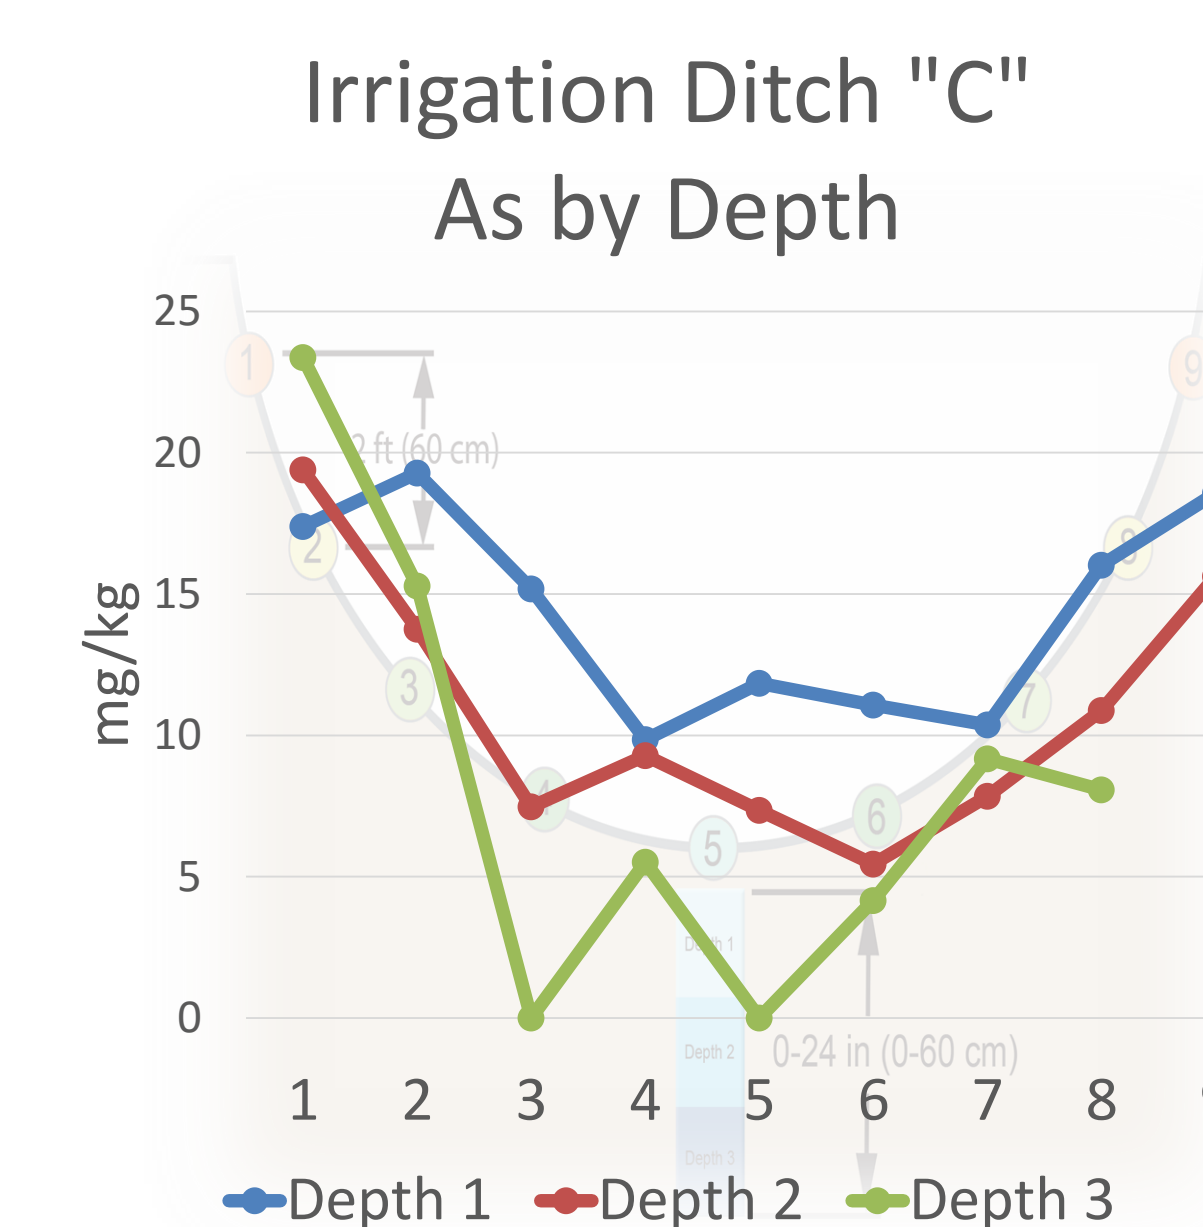
Fig 6: Graphical tracking of each Aluminum (Al), Arsenic (As), and Lead (Pb) across a ditch transect.

- Although we consider the 2015 closed ditch samples as "baseline," the appearance of As, Al, Pb in variable concentrations suggests historical (e.g., 1978 Sunnyside Mine breach) and active/ongoing mine drainage from dozens of closed mines located in the Silverton, CO mining district may have impacted these ditches previously.
- From initial analysis, Pb, Al, and As appear highest in surface layer of ditch sediment compared to the center points (Fig 6).
- Sample points located across from one another within one ditch analyzed were not significantly different in metals concentration.
- No significant difference in metal concentration with depth (0-60 cm) was found (data not shown)
- Current analysis is on one of thirteen ditches sampled. Further analysis is ongoing.
